## Liquefaction-induced damage assessment in Gölbaşı city after the 6<sup>th</sup> February 2023 Türkiye earthquakes

Michela Pulsoni<sup>i)</sup>, Anna Chiaradonna<sup>ii)</sup>, Alper Sezer<sup>iii)</sup> and Paola Monaco<sup>iv)</sup>

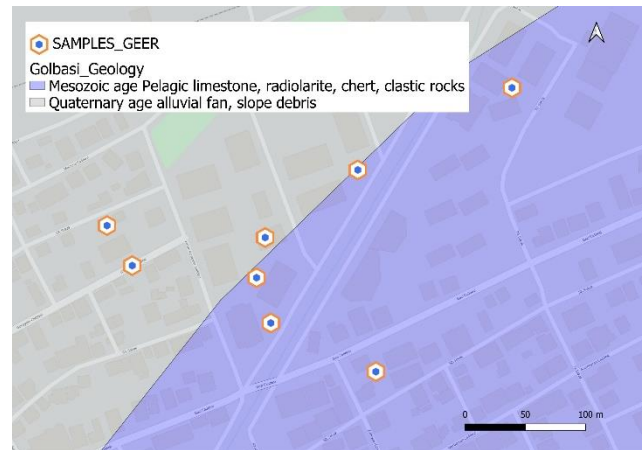
Moug et al. (2023) collected and analyzed some samples of ejected soil in the area shown in Fig. 8. Through this analysis, it was possible to determine the Atterberg limits and the grain size distribution. The fines content varies between 18% and 52% and the plasticity index (PI) is between 9% and 14% (Moug et al. 2023). It is interesting to note that the collected samples fall within two different geological areas.

Fig. 8. Locations of ejecta sampled by Moug et al. (2023) in Gölbaşı on 30<sup>th</sup> March, 2023.

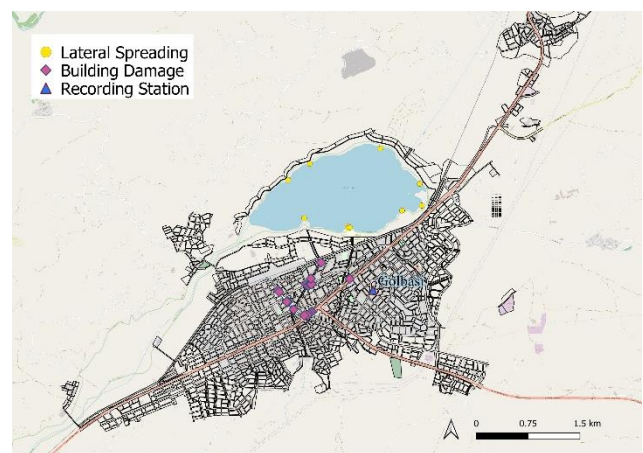
The strong earthquakes that hit the area on February 6<sup>th</sup>, 2023 produced widespread damage and evidence of liquefaction. Fig. 9 provides an overview of the observations collected by the in-situ reconnaissance performed by the Turkish author 10 days after the main seismic events (pink symbols), further integrated with the lateral spreading observations (yellow symbols) reported by GEER (2023). Fig. 10 focuses on the observed building damage in the city, by showing several pictures of the observed failure mechanisms.

Fig. 9. Location of observed evidence of liquefaction and building damage (lateral spreading data retrieved from GEER 2023).

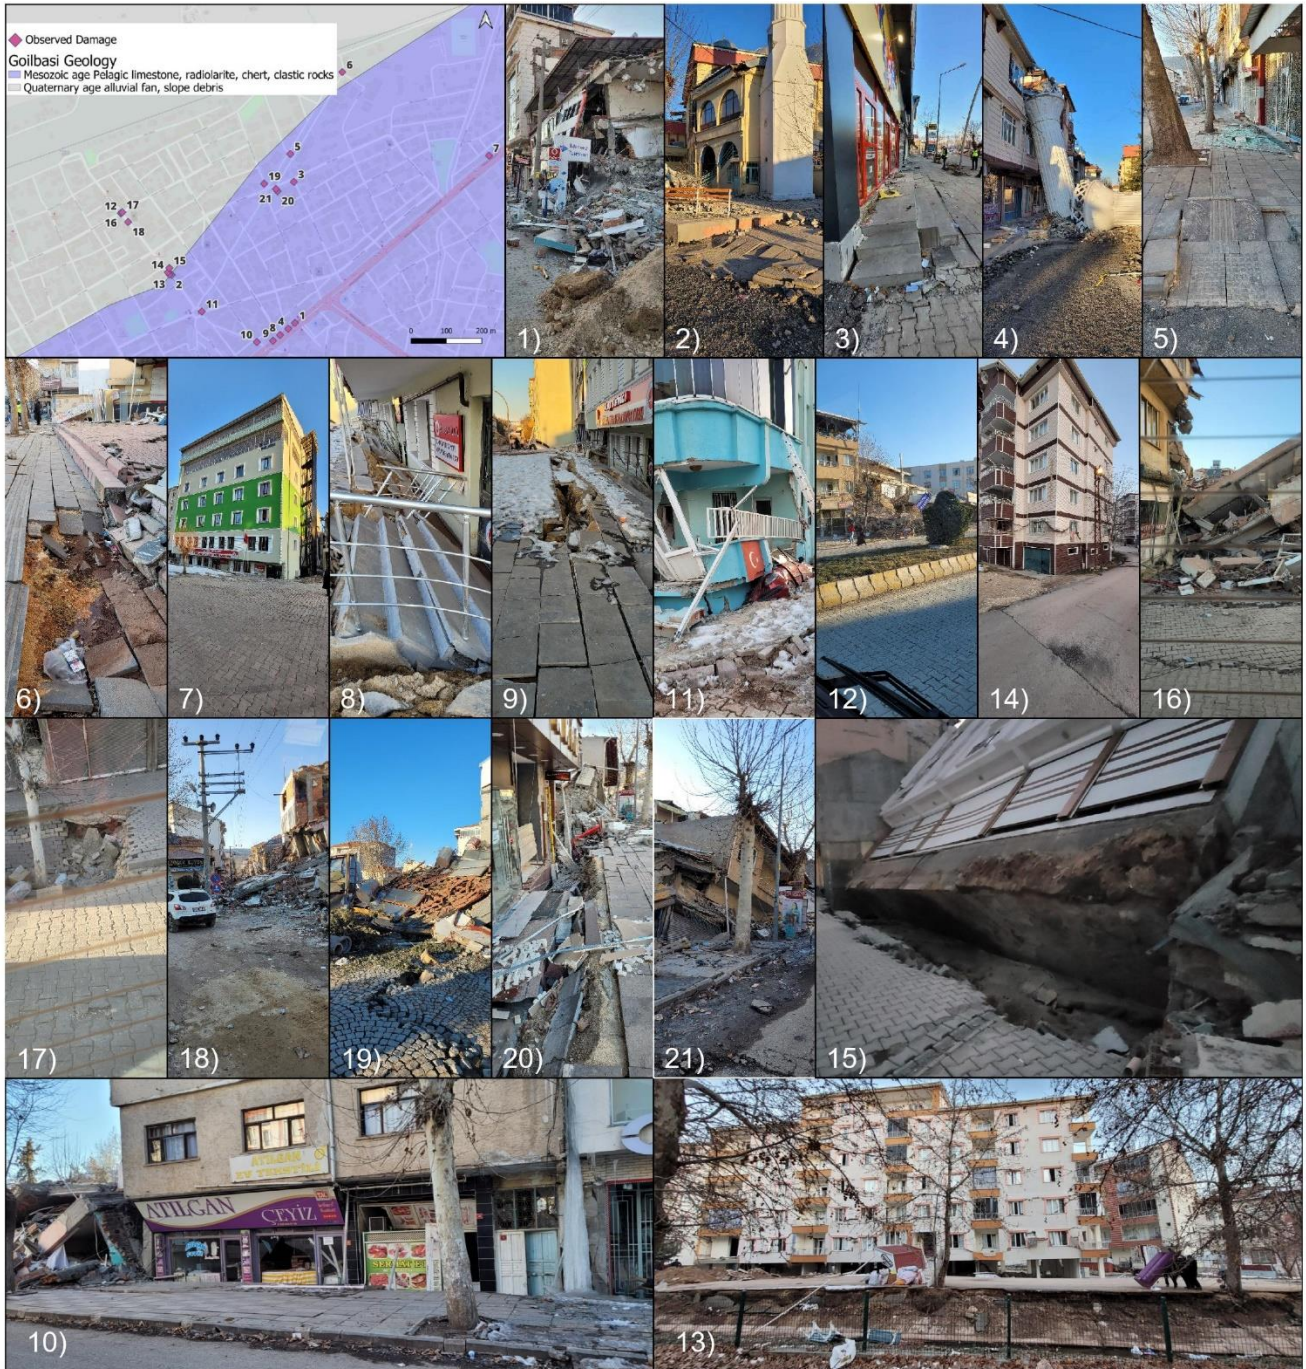
By analyzing the images observed in Gölbaşı after the earthquakes (Figs 9 and 10), a significant amount of lateral spreading, liquefaction and differential settlements can be observed in the city and in many locations near the lake. Manifestations of ground failure with evidence of liquefaction-induced ejecta of silty/clayey sands (e.g., images 6, 19), as well as rigid rotation of shallow foundations with consequent tilting of the building (e.g., image 15), can be observed. The presence of inertia-induced effects, failures due to the out-of-plane mechanisms of walls or in-plane diagonal cracks (Di Ludovico et al. 2020) commonly associated to strong earthquake (e.g., images 1, 16), combined with the liquefaction-induced damages, can also be observed. For liquefaction, the damage caused by inertial forces is mostly absent, because liquefaction works as a natural isolation system for the superstructure (Di Ludovico et al. 2020). This was also experienced by field reconnaissance of the Turkish author: many severely damaged structures exposed to large settlements due to

liquefaction were observed in Gölbaşı (e.g., image 13). Typical damage patterns related to the earthquake-induced liquefaction of the foundation soils, such as punching failure, consolidation settlements (e.g., images 5, 9, 20) and lateral collapses of buildings (e.g., image 7), were also observed.

Fig. 10. Observed building damage due to liquefaction as collected in the field reconnaissance performed by the Turkish author in Gölbaşı.
