Site investigation, monitoring and stability analysis of a built-up slope involved by gas pipeline explosion

ABSTRACT: The paper describes the results of site investigations, monitoring and stability analyses of a built-up slope located near Pineto (Italy). In March 2015 the explosion of a gas pipeline in the upper portion of the slope caused extensive damage to existing buildings and lifelines. Soon after the event, a site investigation and monitoring program was planned. The site investigation included 3 boreholes (25-30 m depth) and 3 flat dilatometer tests DMT (15 to 30 m depth) carried out inside the boreholes by use of the "torpedo" system. The boreholes were instrumented for inclinometer and piezometer measurements. A detailed topographic survey was carried out to reconstruct the ground profile. Hydrological data were analysed for possible critical rainfall events. The slope is formed by OC clay, covered with an upper, 10-14 m thick clayey-sandy silt colluvial layer. The stability of the slope was analysed both in pre- and in post-explosion conditions. The pre-explosion conditions were back-analysed assuming different levels of the groundwater table (at the time of the expl

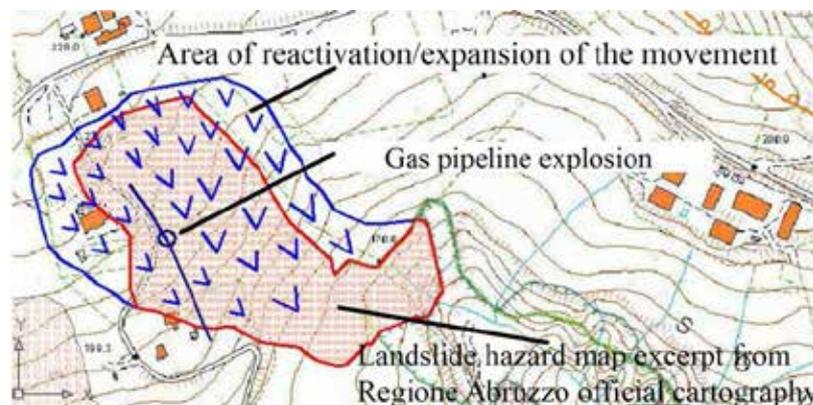
As featured in various maps, including regional ones, the area of Colle Cretone has long been affected by slow movements. Figure 1 shows the area of reactivation/expansion of the movement which occurred on March 6, 2015, involving the gas pipeline. Figure 1 also shows an excerpt from a planimetric map retrieved from official cartography of the Abruzzo regional authority, dating back nearly 20 years ago.

Figure 1. Area of reactivation/expansion of the movement occurred on March 6, 2015, involving the gas pipeline.

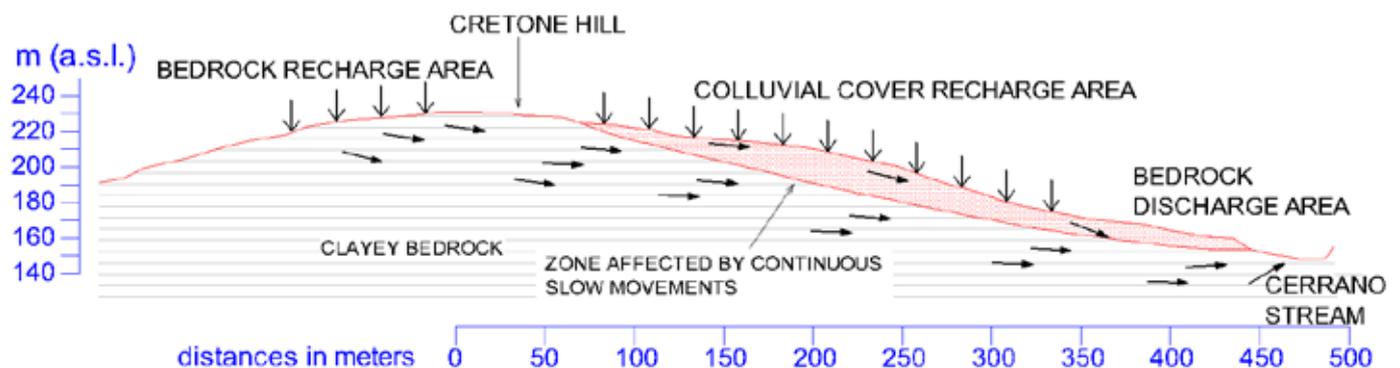
Figure 2 shows a schematic section of the water flow system that affects the slope from Colle Cretone (Cretone Hill) towards the Cerrano stream at its toe. In this context, the continuous influx of storm-water promotes saturation/imbibition of the colluvial cover, causing a reduction of shear strength and thus giving rise to the reactivation of the movement.

Figure 2. Schematic section of the water flow system across the slope.

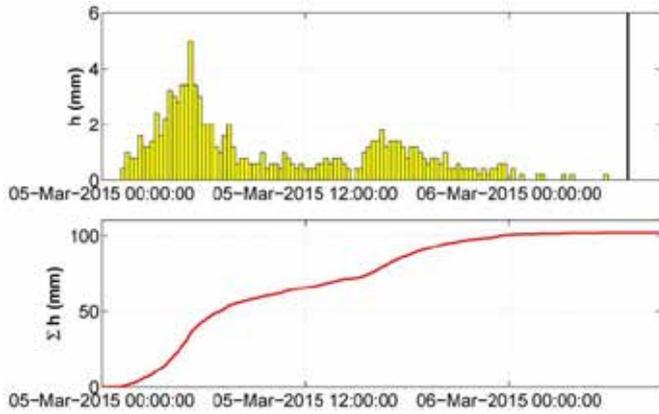
Figure 3. Height of rain recorded by pluviograph (March 5-6, 2015 event).

Figure 3 shows the values of the height of rain recorded by pluviograph. Figure 4 reports the height of rain cumulated during the event. The analysis of the data indicates that the event began on the night of March 5 (01:30 UTC) and lasted continuously until late in the evening (23:45 UTC), with a total height of rain of 102 mm. Peak intensity occurred at 5:15 UTC, in the first stage of the event, reaching the value of 20 mm/hour.

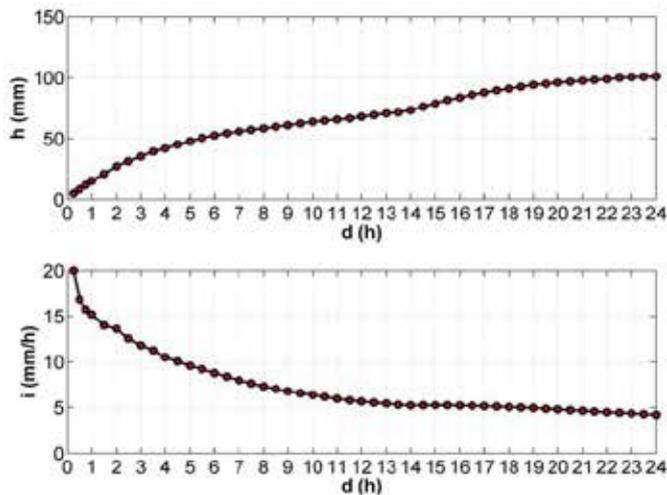
Figure 4. Height of rain cumulated during the March 5-6, 2015 event.

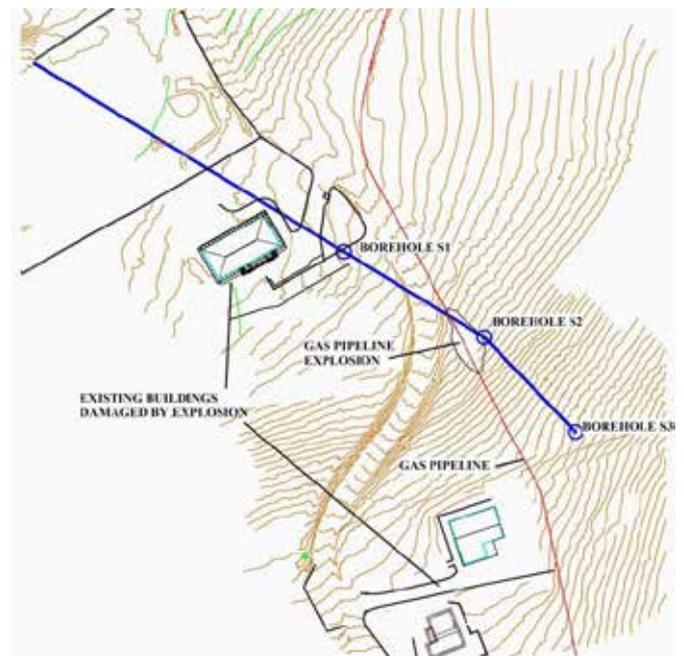
A site investigation and monitoring program was planned soon after the pipeline explosion (Figure 5).

Figure 5. Plan layout of boreholes and DMT tests.

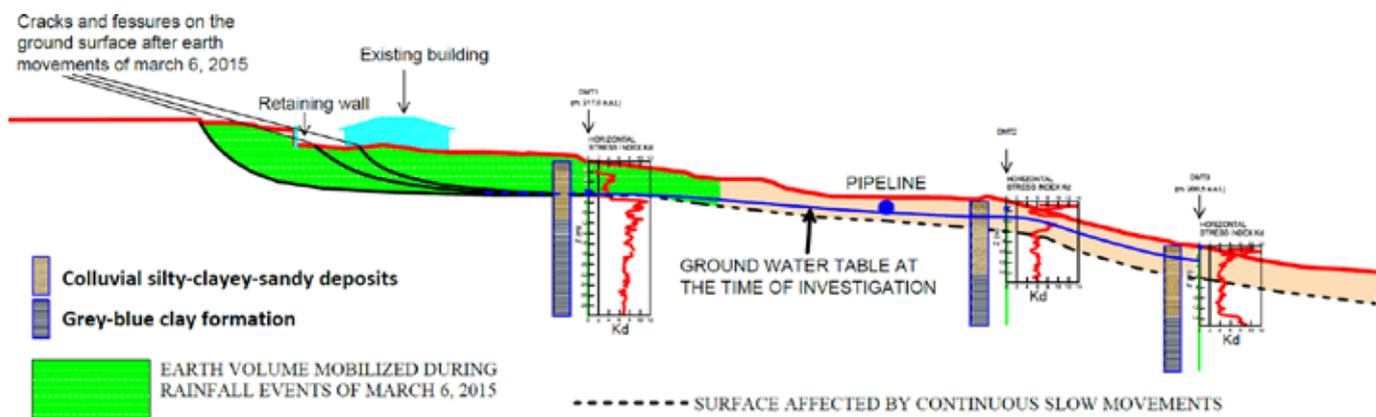
The three borehole logs (Figure 6) show that the upper colluvial silty-clayey-sandy deposit has a thickness varying between 11 m (at the topmost borehole location) and 14 m (at lower elevation).

Significant evidence regarding the thickness of soil above the pipeline involved by the landslide is provided by the K_D profile from DMT 1. The section in Figure 6 shows that, above the pipeline, the soil is quite altered/remoulded to a depth of approximately 7.6 m, with a minimum peak of $K_D \approx 2$ just at that depth. Based on this information and taking into account the location of cracks and fissures on the surface, it was possible to reconstruct the geometry of the landslide mobilised by the rainfall event of March 5-6, 2015.

Figure 6. Longitudinal section of the slope and results of site investigation (boreholes and flat dilatometer tests).

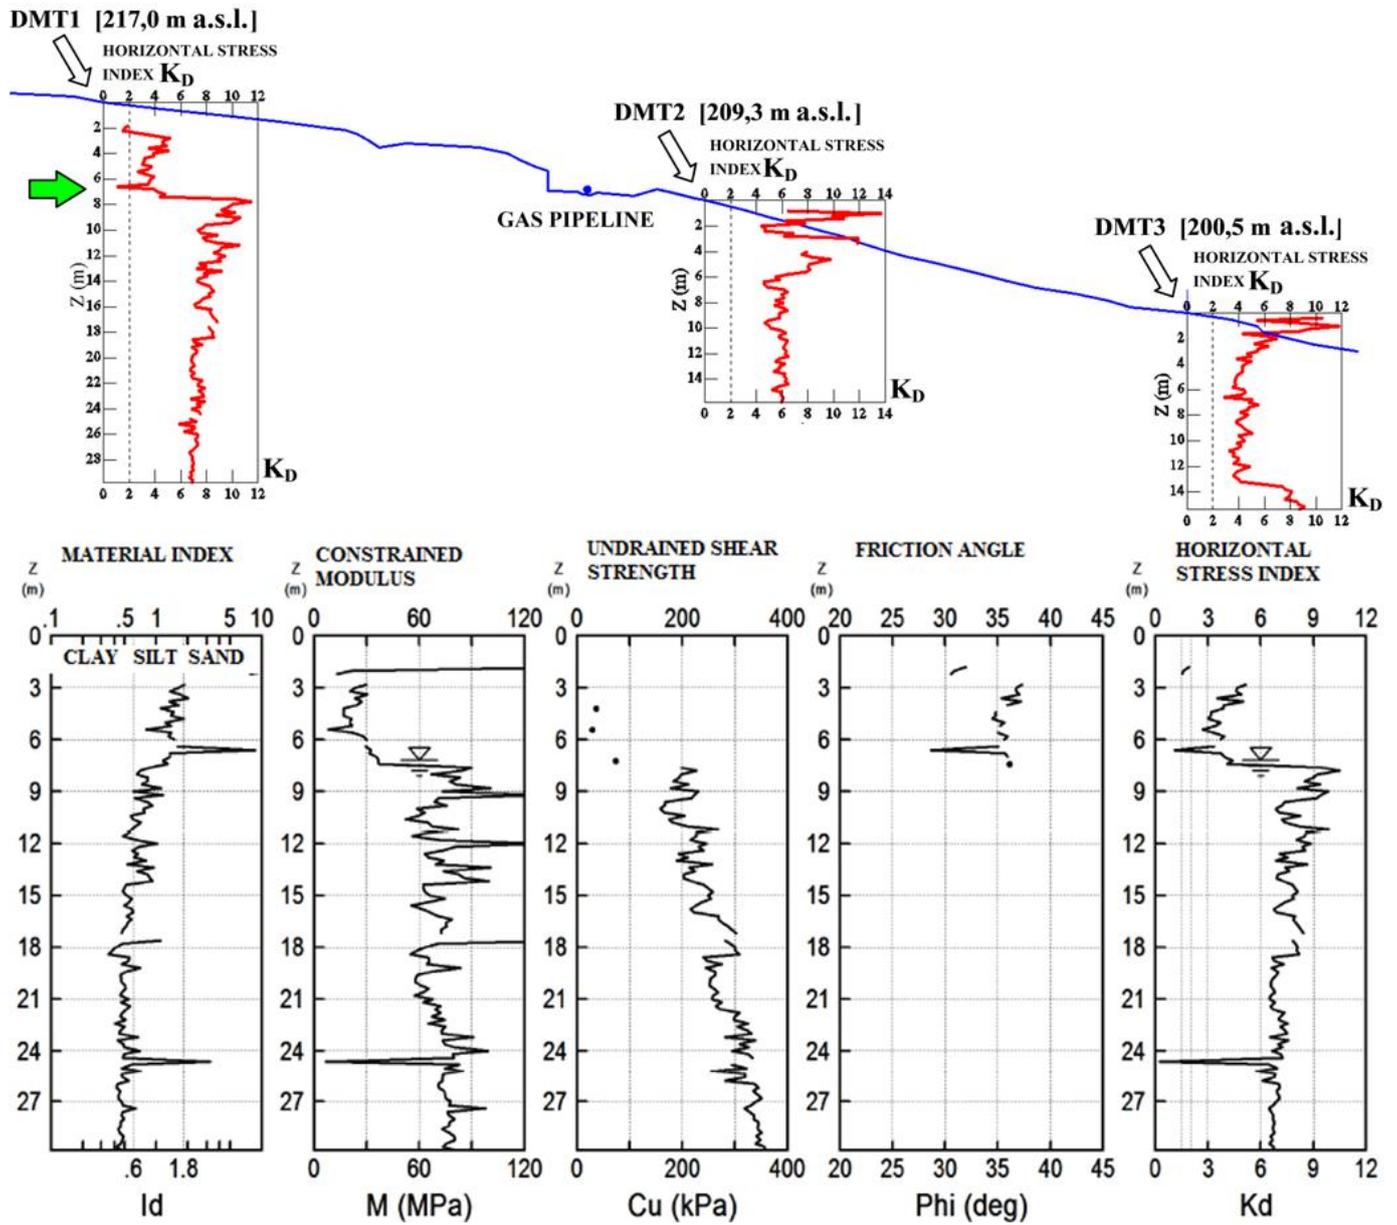
The inspection of the K_D profiles from DMT 2 and DMT 3 (Figure 6 and Figure 7, top) does not reveal any zones with $K_D \approx 2$ or recently remoulded soil layers. Hence it can be concluded that a “neo-formation” roto-translational landslide was triggered on March 6, 2015, involving the portion of slope above the pipeline. The investigation then confirms the geomorphological interpretation, which indicates an extension due to retrogression of a pre-existing slow slope movement.

Figure 7 shows the profiles of the constrained modulus M and of the undrained shear strength c_u obtained from DMT 1. It can be noticed that the landslide, by remoulding the soil, has produced a substantial deterioration of the mechanical properties in the upper 7-7.5 m.

Figure 7. Profiles of K_D from all DMTs (top) and parameters interpreted from DMT 1 (bottom).

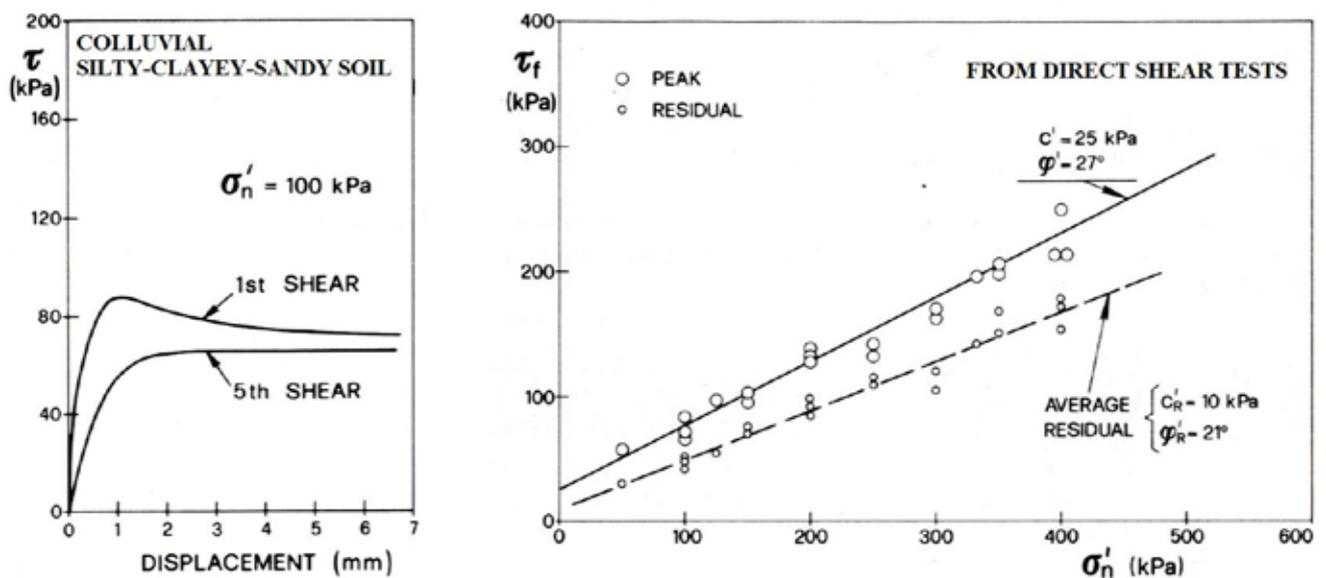
Direct shear tests, with measurement of the residual shear strength after several reversal cycles, were executed on samples retrieved from the colluvial, soft to stiff (when dry) clayey-silty-sandy layer. Figure 8 (left) shows typical shear strength vs. horizontal displacement curves. The interpreted shear strength values are shown in Figure 8 (right). The relatively high values of the residual friction angle of the soil may depend on the scarce activity of the clay minerals.

Figure 8. Results of direct shear test on a sample retrieved in borehole S1 (depth 6.00 m).

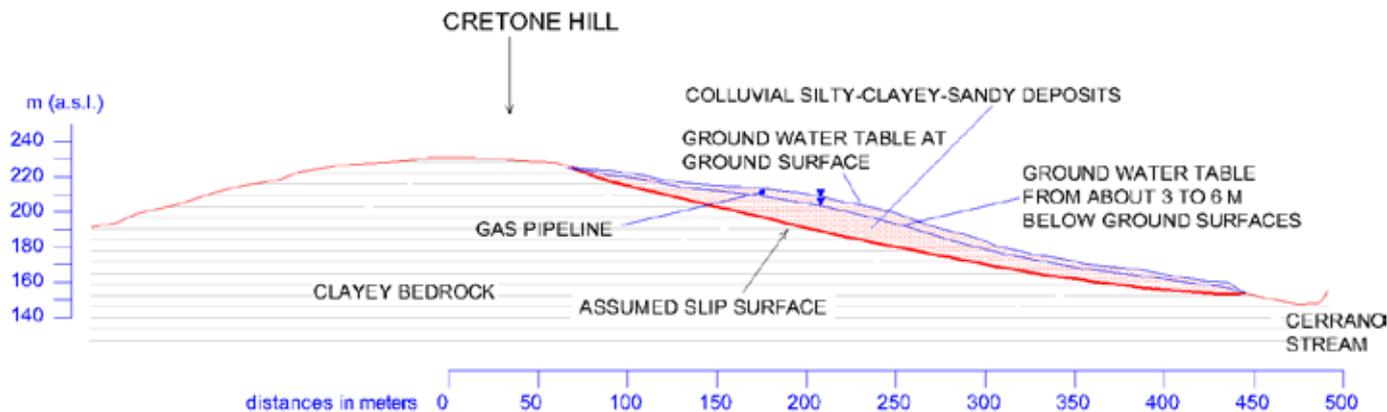
The stability of the slope in the zone of the landslide occurred on March 6, 2015 was back-analysed assuming two different ground water conditions (Figure 9): (1) ground water table at ground surface; (2) ground water table from about 3 to 6 m below ground surface.

If the peak shear strength is assumed in the colluvial cover, the safety factor (F_s) variations are scarcely influenced by changes in pore water pressures. If one refers to the residual shear strength, the values of F_s vary from 0.95 to 1.05. Such values may explain well the movement of the colluvial cover.

Figure 9. Slip surface and ground water conditions assumed in the back-analysis.
