Integrated non-destructive assessment of relevant structural elements of an Italian heritage site: the Carthusian monastery of Trisulti

To cite this article: C Rainieri *et al* 2015 *J. Phys.: Conf. Ser.* **628** 012018

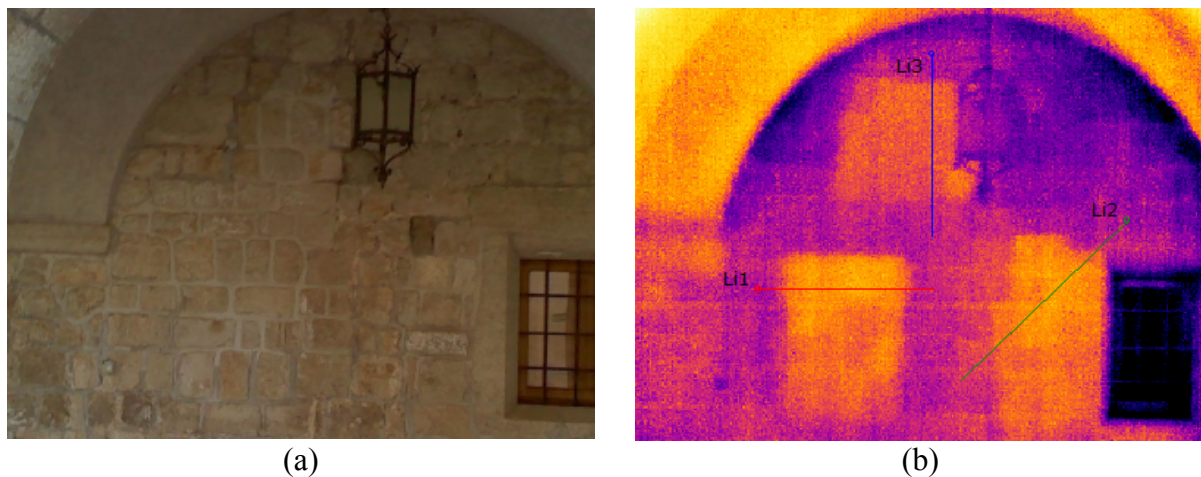
The infrared thermography has provided interesting information about the evolution of the building. In fact, it showed that some openings (Figure 2) were closed after interventions (probably in 1958, as resulting from the analysis of the literature) aimed at restoring the original configuration of the building. Such interventions could not be easily recognized by exterior visual inspections.

Figure 2. Digital (a) and infrared (b) image of the outer wall of the Library

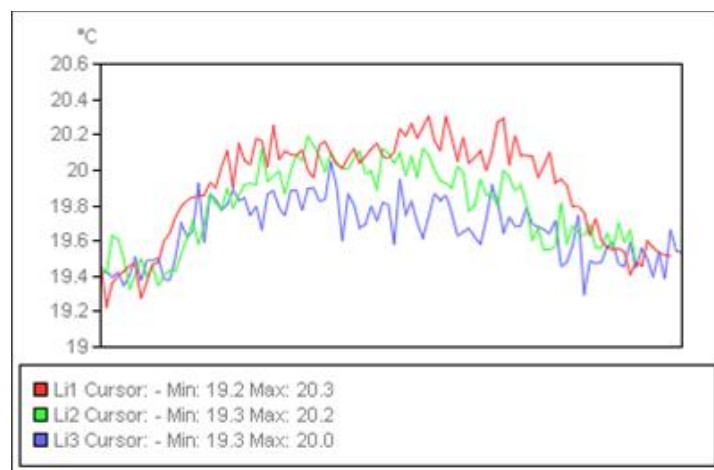
Figure 3. Temperature profile of the segments Li1, Li2, Li3 of Figure 2

The analysis of the infrared image highlights three portions of the wall characterized by a slightly higher temperature with respect to the rest. The analysis of the thermal profiles along three segments intercepting these areas shows that they are comparable (Figure 3), denoting common characteristics of the material in these areas.

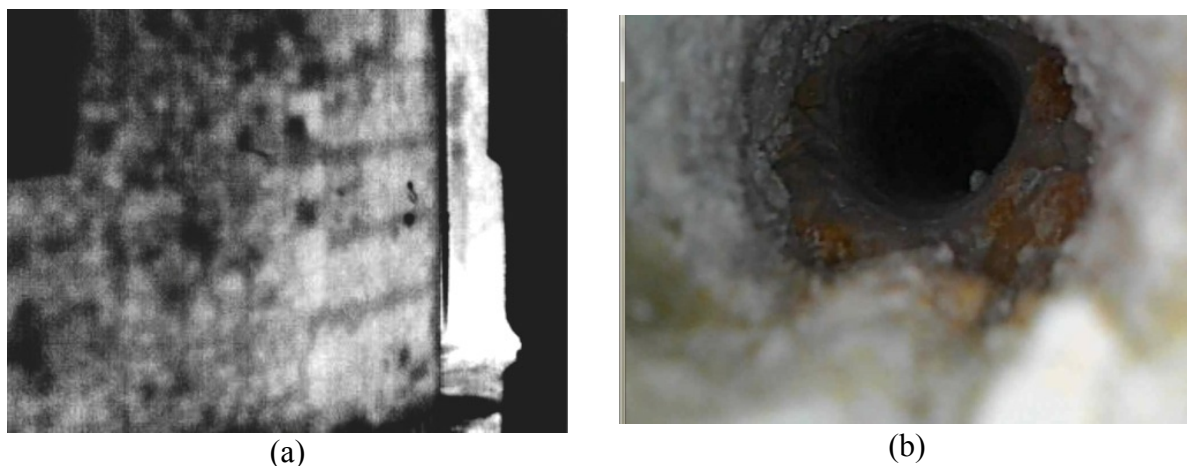
Figure 4. Masonry Class A1/II: infrared image (a), endoscopic image (b)

- *Class A1 - Group II*: irregular masonry characterized by the presence of compact limestone and other materials (travertine and bricks), and corners made by large stone blocks (Figure 4).
- *Class A3 - Group I*: masonry made by compact limestone with lime mortar and aggregates; the texture is homogeneous and undifferentiated; this class of masonry is also characterized by the presence of adjustments of horizontality along the height (Figure 5).

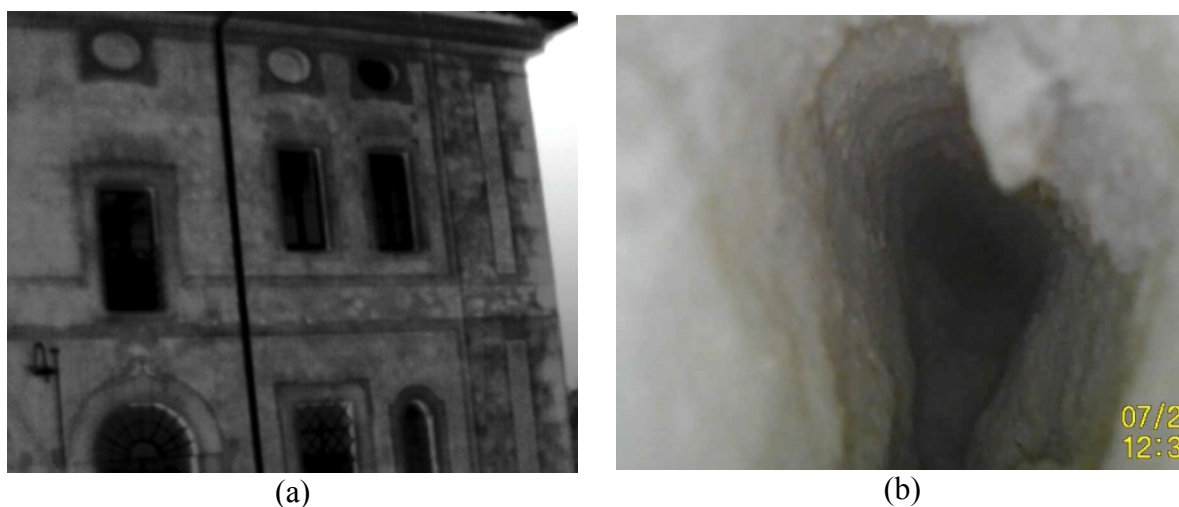
Figure 5. Masonry Class A3/I: infrared image (a), endoscopic image (b)

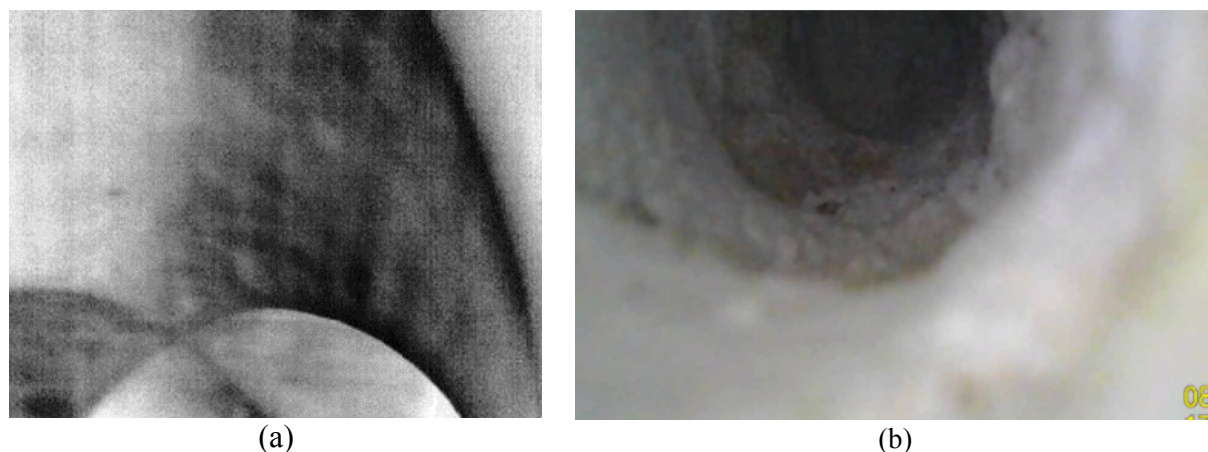
The combination of thermography and endoscopy has revealed its potential in the analysis of the vaults (Figure 6) confirming some assumptions based on the historical research [3] and literature reviews [5].

Figure 6. Vault in the portico of the Library: infrared image (a) and endoscopy (b)

The vaults were made of limestone with elements arranged in form of shell ("*in foglio*"). It was also recognized that the stone slabs have been put with the broader face along the intrados of the vault, then cemented with mortar.

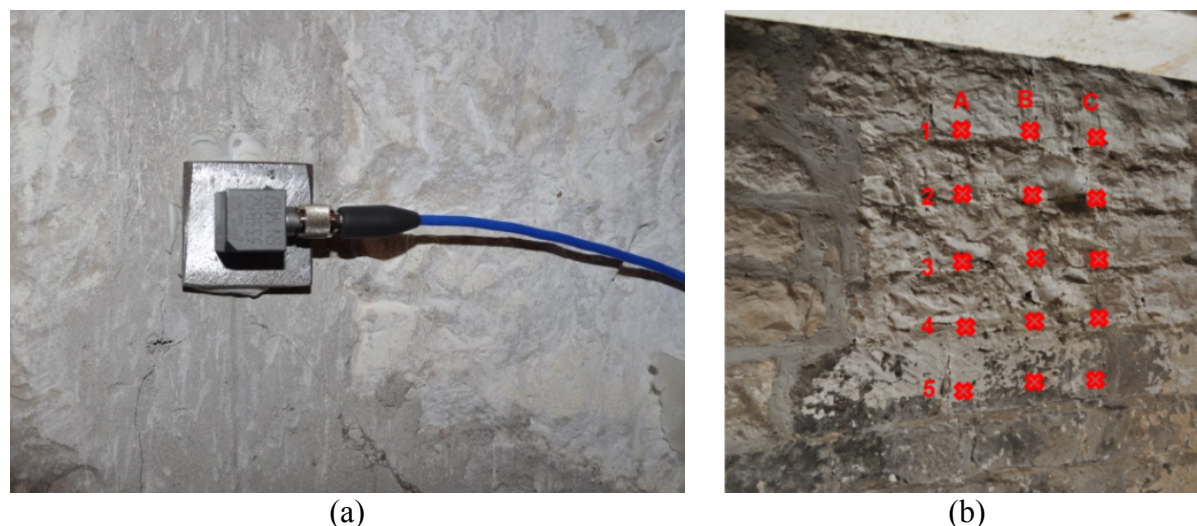
Figure 7. Sonic tests: sensor (a) and measurement mesh (b)

Direct sonic tests, aimed at obtaining qualitative information about texture and homogeneity of the walls, have been performed at the Library of the Carthusian Monastery of Trisulti. The sensors were arranged according to a regular mesh grid (20 cm spacing in both x and y direction) on the investigated wall surfaces (Figure 7).

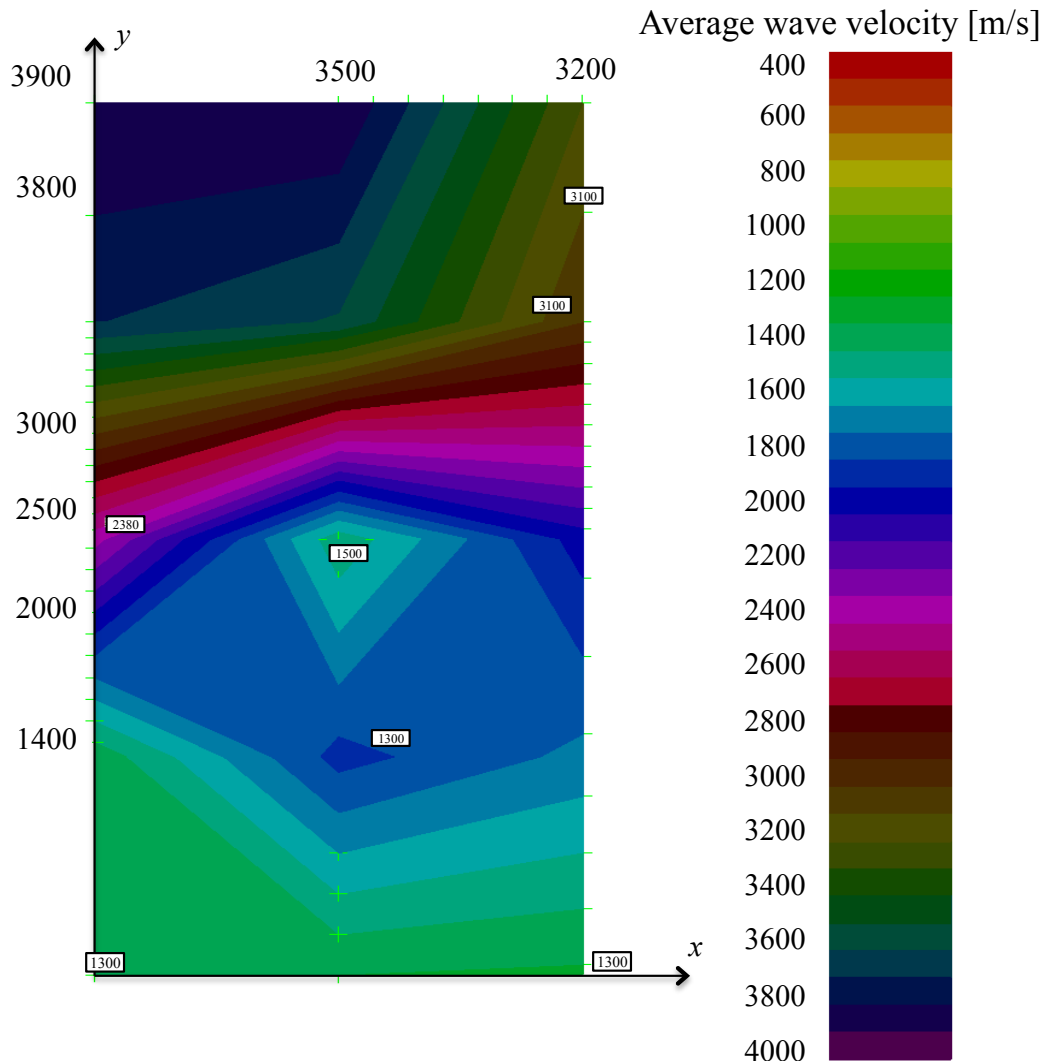
The sonic tests highlighted a discontinuity in the response of the masonry between the upper and lower part of one of the outer walls of the Library (Figure 8). It was probably due to the reconstruction of the upper part of the wall during the past. The discontinuity of material was visually detectable and also confirmed by the infrared thermography.

Figure 8. Mapping of average wave velocity

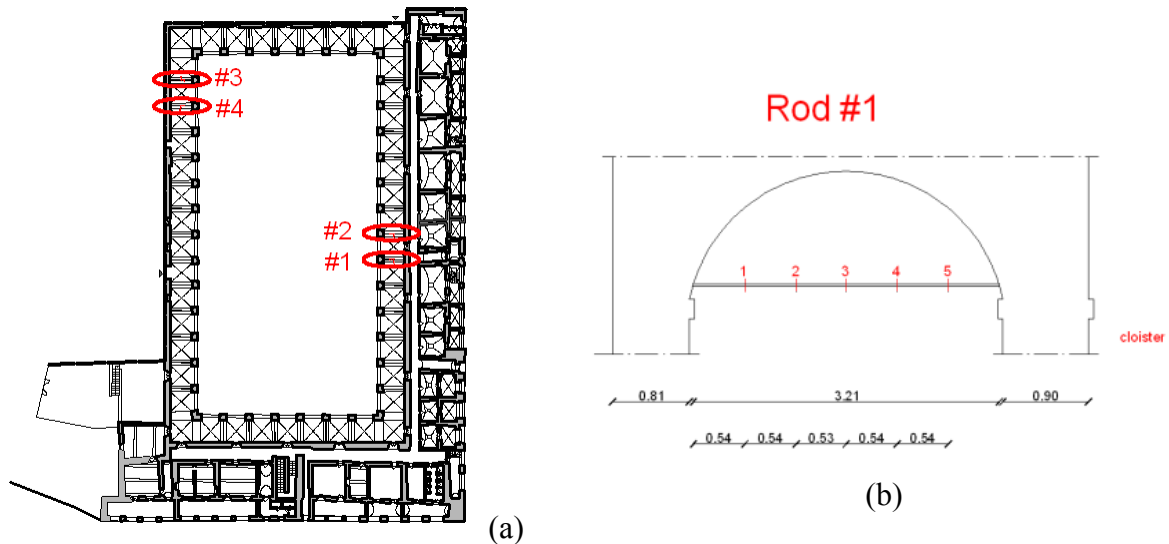
The analysis of documents collected in the Public Archive in Frosinone highlighted that, after the restoration interventions carried out in 1936, the tie-rods in the cloister of the Monastery were not tensioned, so that they could be activated by external loads such as the earthquake. Non-destructive vibration-based tests have been therefore carried out to estimate the tensile load [7] in four tie-rods of the cloister of the Carthusian Monastery (Figure 9) and assess their role in the current equilibrium condition of the structure.

Figure 9. The tested tie-rods (a) and sample sensor layout (b)

Reference values of 210 GPa and 7800 kg/m³ have been adopted for the Young's modulus and the density of the steel, respectively. Stable estimates of the tensile loads have been obtained, as reported in Table 1. The results point out that the investigated tie-rods are subjected to tensile loads in operational conditions.

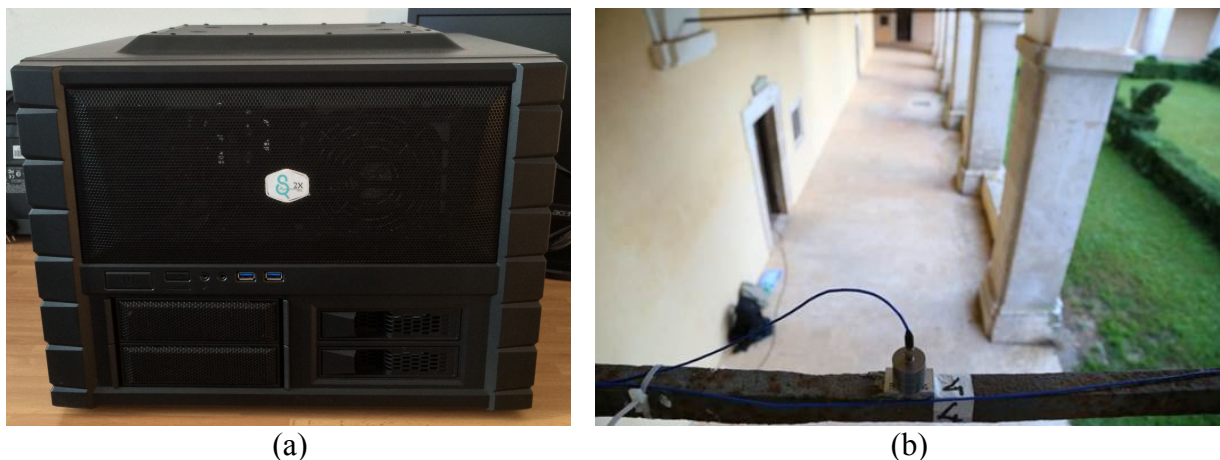
and automatically process the ambient vibration response of cables and tie-rods, providing estimates of the fundamental modal properties and the tensile load in operational conditions [7]. The portable system (Figure 10a) for in-situ evaluation of tensile loads in tie-rods consists of two boards working in parallel. The first board is dedicated to data acquisition and storage, while the second carries out the automated modal parameter identification and the estimation of the tensile load.

Figure 10. Vibration-based testing of tie-rods: measurement system (a), installed sensor (b)

The system can acquire data from a maximum of eight IEPE accelerometers by means of the integrated NI PCI 4472b board. The system is complemented by a set of seismic, miniature (50 gm) IEPE accelerometers (Figure 10b). The characteristics of the sensors are: 10 V/g sensitivity, 0.7-450 Hz bandwidth, 0.5 g pk full-scale range. The data acquisition system is characterized by 24-bit Sigma-Delta ADCs for simultaneous sampling of the eight channels, analog antialiasing filters, 110 dB dynamic range, 102.4 kHz maximum sampling rate.
