Automatic three-dimensional features extraction: The case study of L'Aquila for collapse identification after April 06, 2009 earthquake

Abstract

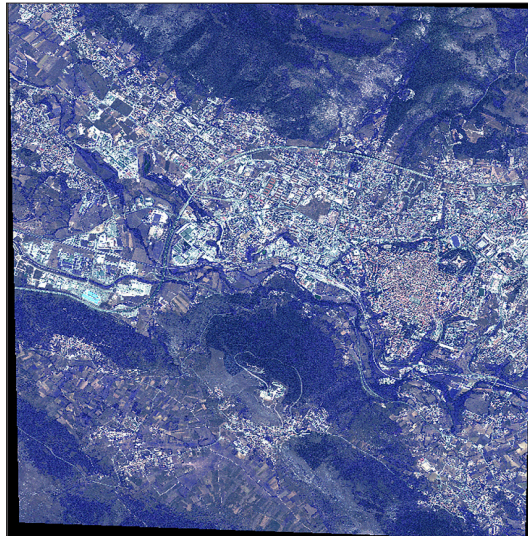
Figure 1 - WorldView-2 image of L'Aquila (figure is approximately 50 Km²).

For the test area, a very high resolution WorldView-2 satellite monoscopic image was acquired. The new generation of VHR optical images (≤ 1 m), such as WorldView-2, enable the detection of minute changes on the surface; they also introduce some new problems related to the large amount of information being gathered, which were not encountered with the previous sensors [Dell'Acqua et al., 2011]. The image displayed in Figure 1 was acquired on August 9, 2010, a few months after the main seismic event took place. It covers about 50 km² of the historical centre of the city, extending also to rural and peripheral areas.

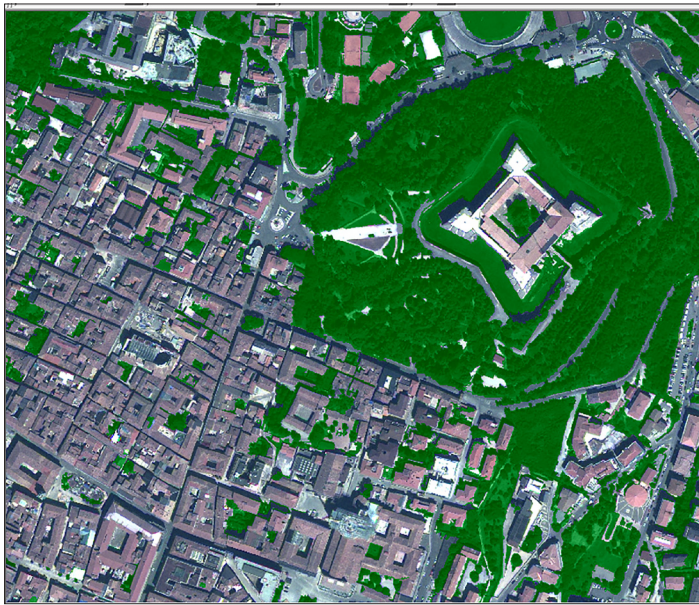
Figure 6 - Classification of vegetated areas through NDVI.

channels 5 (red channel) and 7 (near infrared channel) of the WorldView-2 image. Then a threshold was chosen to accurately assign the objects to the vegetation class for the specific characteristics of the images; one must remember that, due to the elevated number of bands (8) in this satellite, the interval in each single band is different from that of the most diffused, four-band satellites [Padwick et al., 2013]. The result obtained from the NDVI classification is displayed in Figure 6.

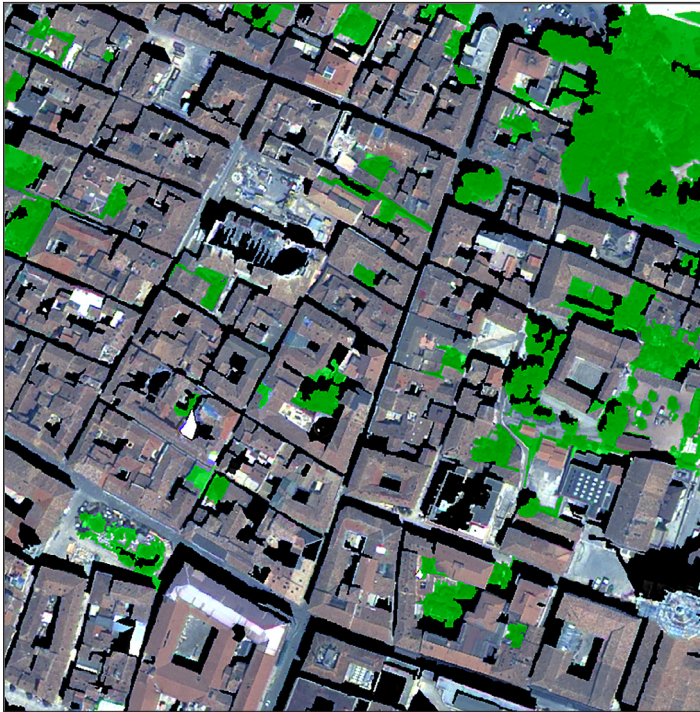
Figure 7 - Classification of shadows through brightness features.

A detailed explanation of this phase is omitted from this article for issues of length, but a complete description can be found in a previous paper [Baiocchi et al., 2013]. A literature review revealed the concern that use of the NDVI for the elimination of vegetation from further data processing steps carries the risk that the shadowed parts of the buildings will also be eliminated from the processing [Grigillo et al., 2011]. For this reason, the same procedure was used to classify the shadows in the image. In this case, a predefined feature of brightness was used, so after the most appropriate threshold of brightness was chosen, the unclassified objects from previous classifications were assigned to the shadows class (Fig. 7).

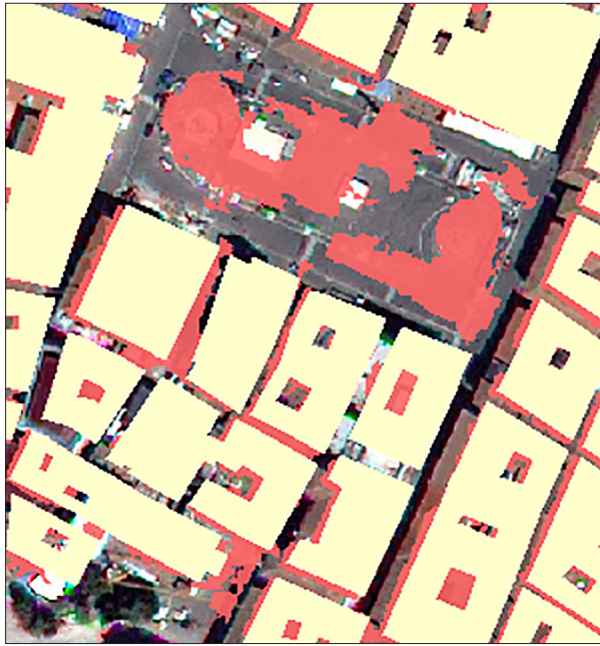
Figure 14 - Classification mistakes; the algorithms (red color) classify some paved areas as buildings not present in CTR buildings (yellow color).

With regard to the third calculation, 9 probable “new buildings” were actually classification mistakes (the classification algorithms seem to incorrectly classify shadows or paved areas

as buildings because they share a similar radiometry to the roofs; Fig. 14) while 5 buildings were not present on the CTR. The latter buildings weren't new because the area is a historic centre; most likely, they were not classified as 'Buildings' in the database linked to the official cartography.

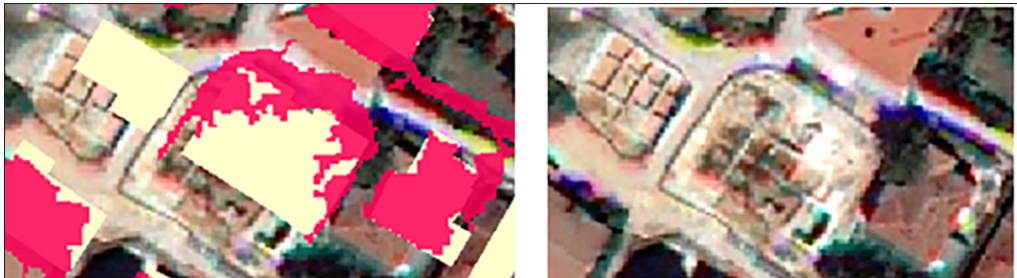
Figure 15 - Buildings collapsed and not identified by classification algorithms (red color)but reported on cartography (yellow color).

Regarding the 9 probable collapsed buildings identified by the classification, 3 were actually collapsed buildings (for example, Fig. 15) while the other 6 were classification mistakes; in this case, the algorithms may have assigned some buildings' image objects to another category.

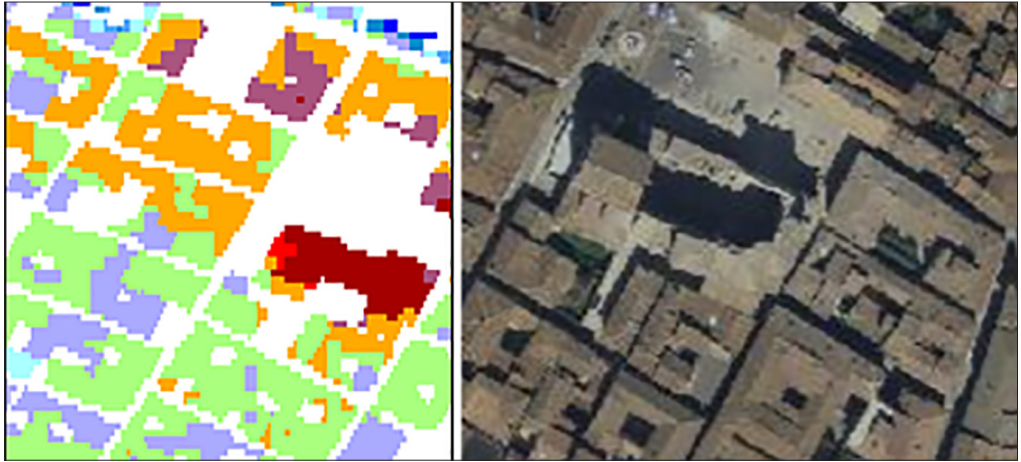
Figure 17 - The identified collapse of Santa Maria Paganica Church with height differences.

In the same subset of previous tests, the methodology reveals 6 possible collapses: 3 are actual collapses (for example, Fig. 17), whereas the remaining differences between pre- and post-earthquake models are due to some misclassification.
