SEISMIC ASSESSMENT OF DAMAGED MARGHERITA PALACE USING APPLIED ELEMENT METHOD

Abstract

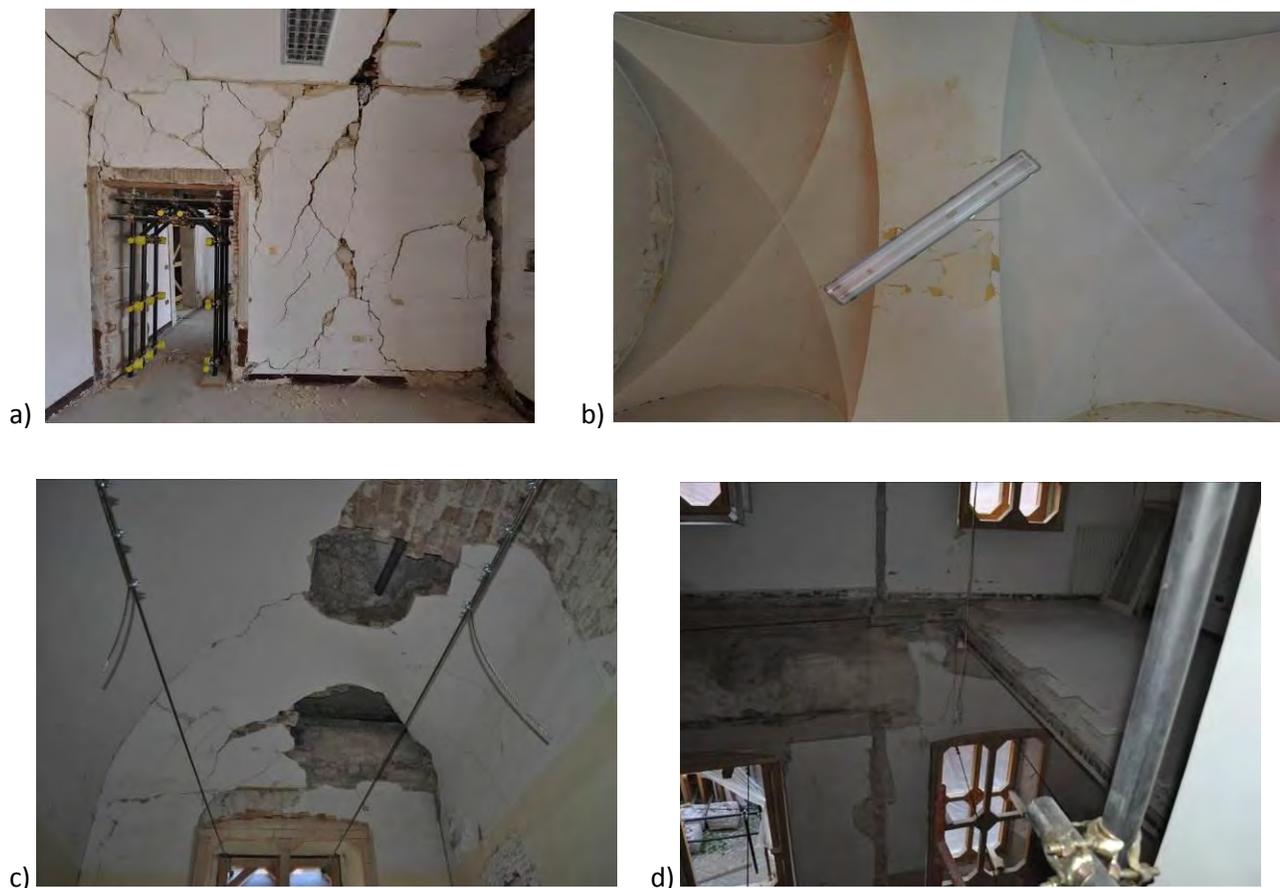
Fig. 4 – a) Diagonal cracks due to in plane action resulted in extended portions of the resisting walls: out of plane displacement have been recognized in few front walls of the building; b) typical geometry of cross vaults system; c) partial collapse of a trough vault; d) Part of a floor collapsed as consequence of the joist ends disengaged from the sustaining wall.

masonry typologies were recognized, probably as a result of restoring and retrofitting interventions done during the past centuries. The overall poor connection among orthogonal walls and the inhomogeneous masonry in the walls thickness were certainly causes for the heavy structural damages suffered during the April 2009 earthquake (Fig. 4a). At the first level, all the rooms present a roof consisting of single or a double curvature vaults made of bricks. Trough vaults, groined (cross) vaults, cloister vaults and ribbed vaults are largely diffused in the building (Fig. 4b). These structural systems are part of the floor package usually including a variable thickness of filling material, a few centimeter thick layer of poor concrete, a few centimeter thick layer of mortar, then a marble pavement. The vaults system suffered heavy damage (Fig. 4c), with longitudinal cracks frequently due to the unrestrained displacement (overturning) of the sustaining walls. At the second level, all the rooms have a flat roof which structurally consists of steel joists (spaced each 0.8m-1.0m) and supporting long hollow blocks. Simply supported steel joists are oriented parallel to the shorter dimension of the rooms. At the two ends, the joists are inserted into the wall thickness for about 0.25 m. Nothing, other than simply friction, prevents the lateral disengagement at the extremities of the steel joists. Actually, this lack of restraint caused the collapse of floors during the earthquake (Fig. 4d). A traditional gable roof consisting of wood truss, secondary wood elements, planking, and brick tiles covers the building.

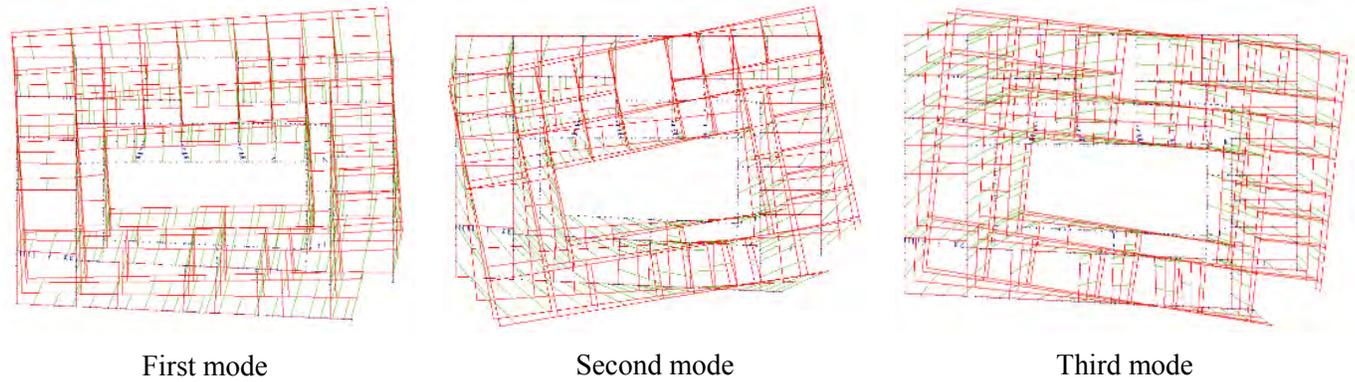
Fig. 6 – Modal properties of the structure.

First, an elastic analysis was carried out to evaluate the stress concentration in the structures subjected to vertical loads only (gravity and service loads). The predicted stress level into material was qualitatively compared to actual stresses measured in situ. Although more sophisticated analyses were possible (see next section), hypotheses concerning the poor connections among orthogonal masonry walls, the reduced in plane stiffness of the floors and the real mass distribution were assumed in a simplified manner when considering the elastic numerical model of the building. Numerical simulations confirmed all these hypotheses strongly influence the predictions of the local and global form of collapses of the building, also predicted. Modal properties of the building are summarized in Table 2 and in Fig. 6.

Mode n.	Period [sec]	Mass X [%]	Mass Y [%]
1	0.270	0.43	82.67
2	0.238	18.90	6.23
3	0.228	69.85	0.34
