Ph.D.ICEAA
Dottorato di ricerca in Ingegneria Civile, Edile-Architettura, Ambientale
XXXII ciclo

REINFORCED CONCRETE IN RESTORATION WORKS OF MONUMENTAL BUILDINGS

Study of the Interventions Conducted among
Central Italy and Southern Part of United States
in the Twentieth Century

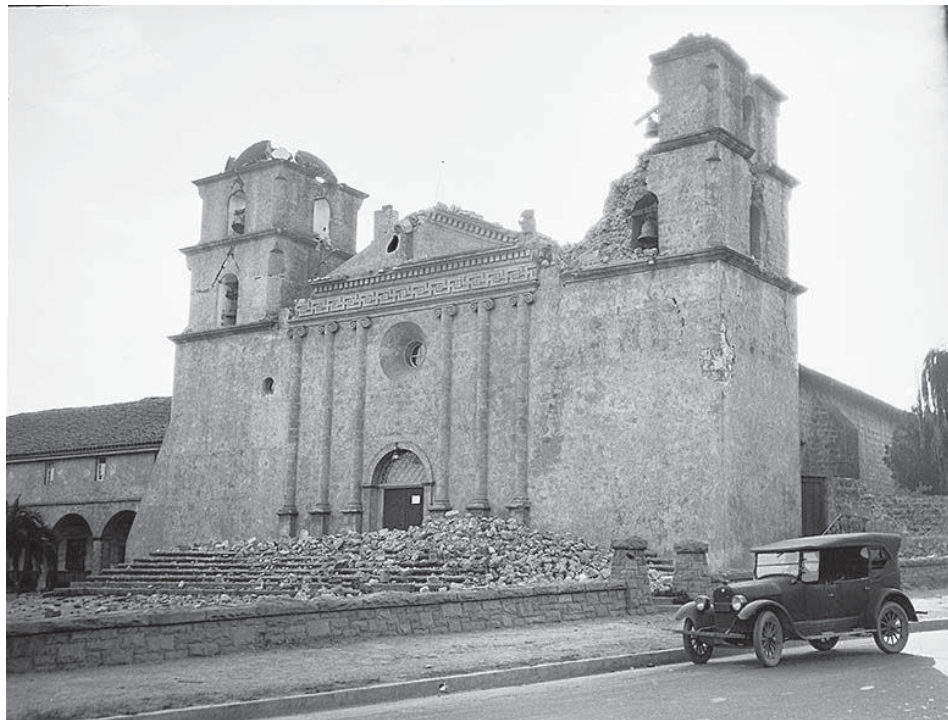
Fig. 4.24
The mission of Santa Barbara after the earthquake of 1925 (UCLA).

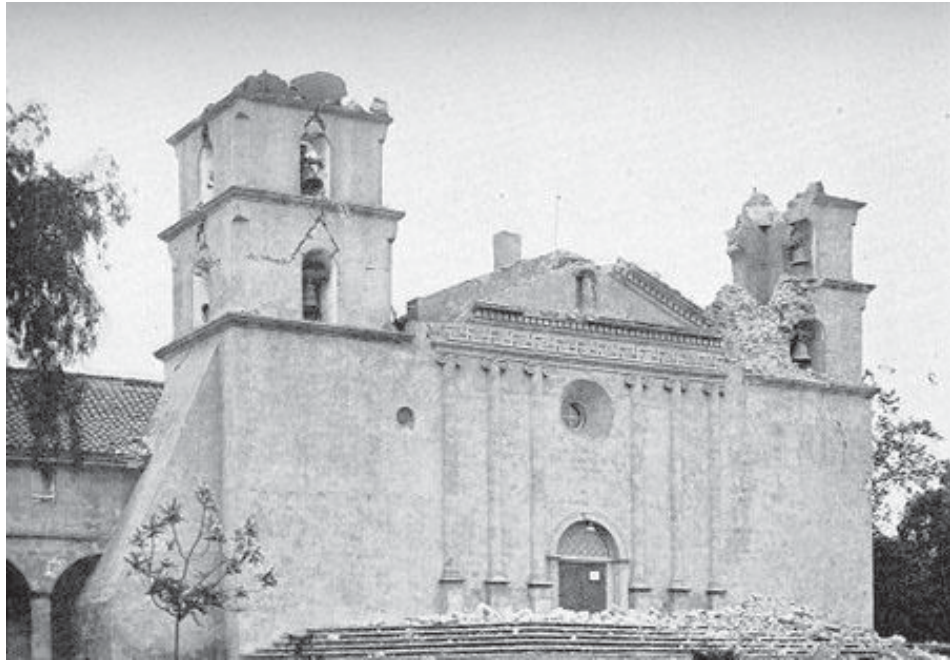
Fig. 4.25
Picture of Mission Santa
Barbara after the
earthquake of 1925
(USCS).

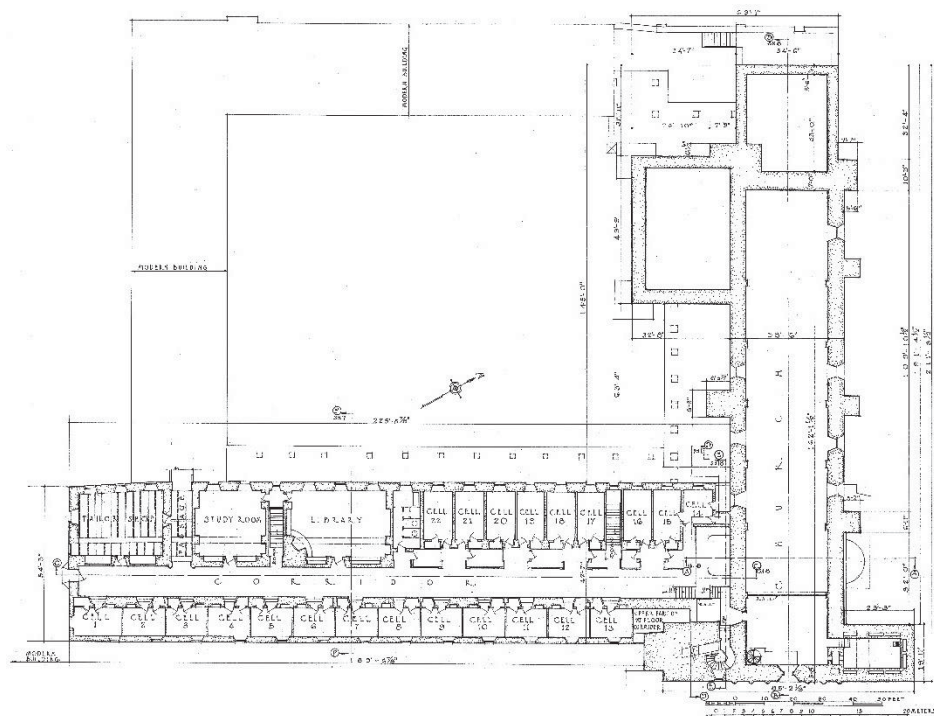
Fig. 4.30
General plan of the mission of Santa Barbara (HABS).

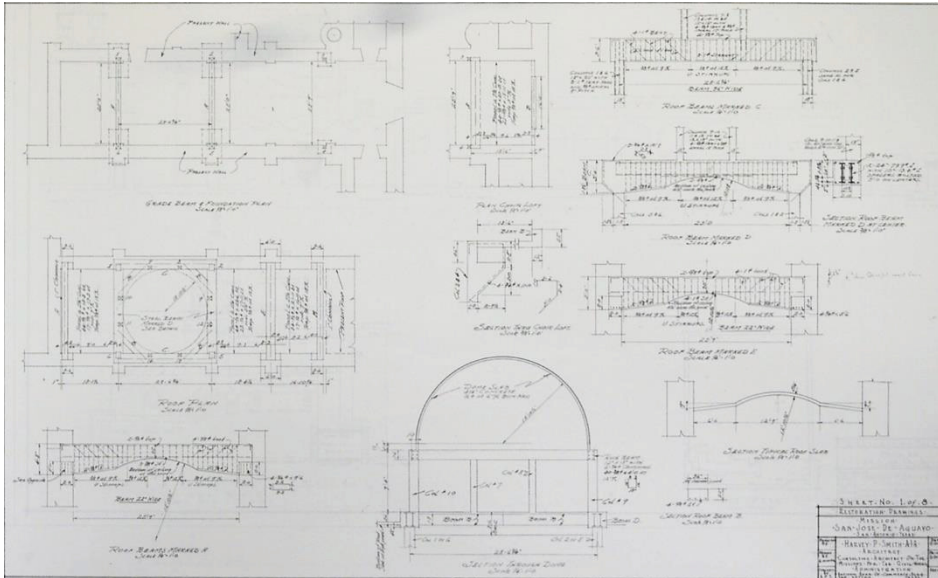
Fig. 4.47 Restoration drawings by Harvey Smith. Details of the elements in reinforced concrete and scheme of the new dome. (1934). (NPSSA)

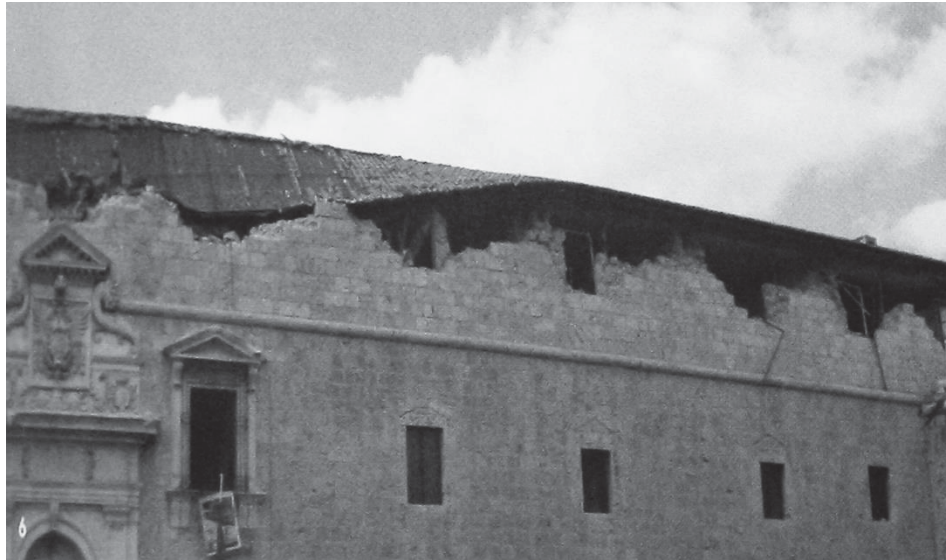
Fig. 5.2
 Damages on the Castle of L'Aquila after 2009 quake event. The top beams pushed out of the plane the masonry.

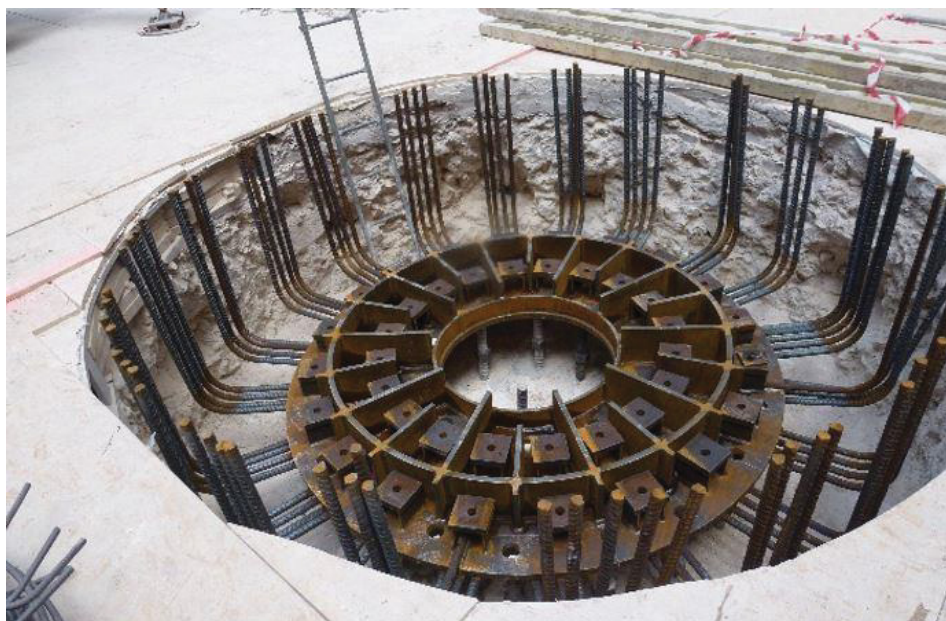
Fig. 6.1
The foundation of the new pillar in reinforced concrete of the reconstructed area.

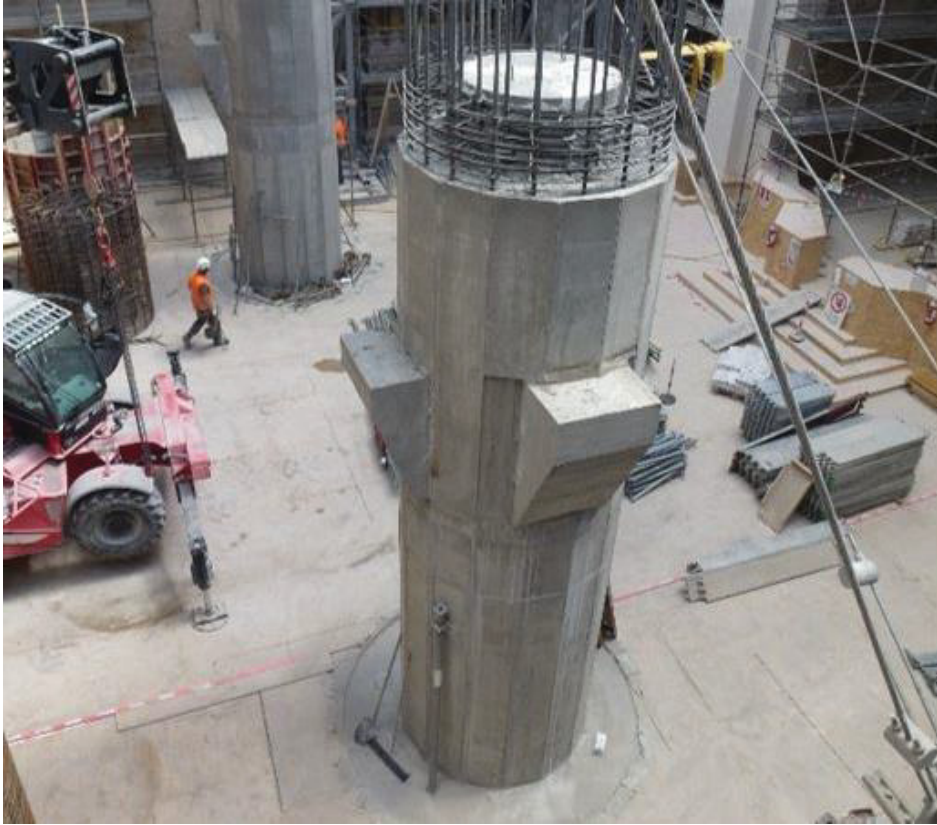
Fig. 6.2
The new pillar in reinforced concrete, realized in the reconstructed area.
