ANALYSIS OF CASE STUDIES IN
RECOVERY AND RECONSTRUCTION

THE CONSERVATION OF PALAZZO CARLI-BENEDETTI AFTER THE 2009 EARTHQUAKE IN L'AQUILA (ITALY)

Carla Bartolomucci, Donatella Fiorani

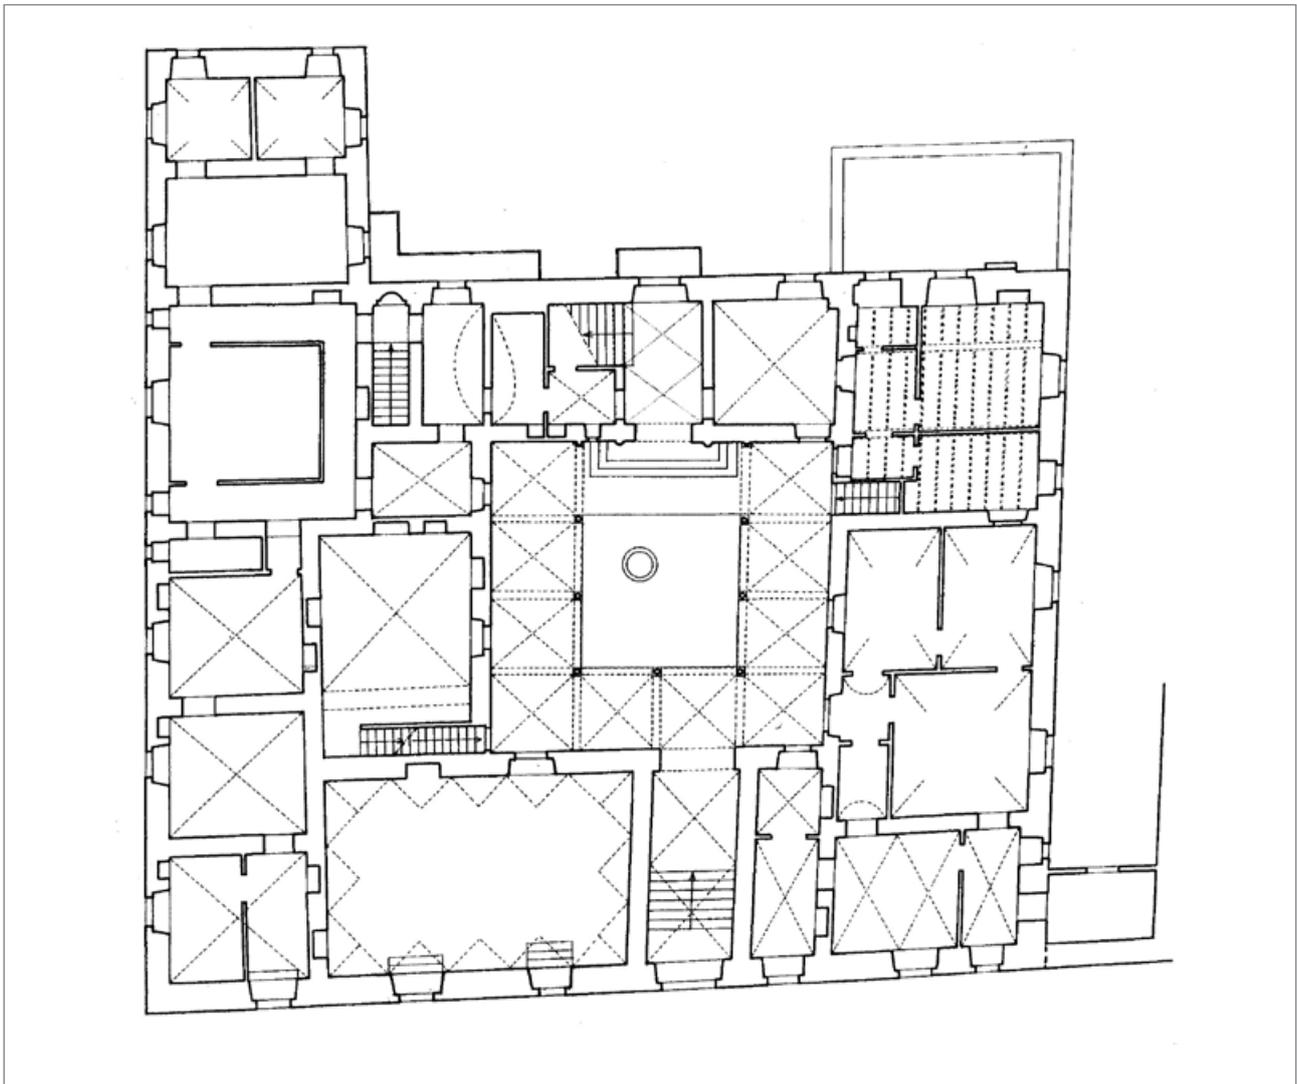
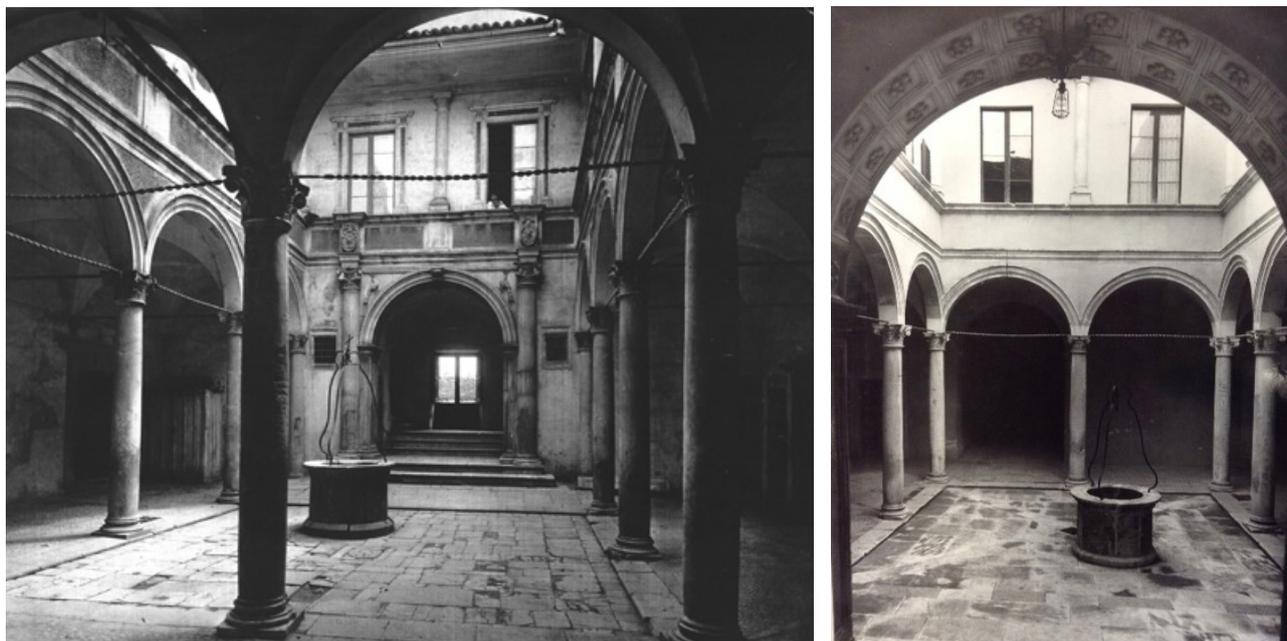
▼
Fig. 2. The plan of Palazzo Carli Benedetti at courtyard level – intermediate floor (drawing by C. Bartolomucci, 1999)

The walls are composed of irregular masonry in stones with squared cornerstones. The vaults of the first level are in stone, those of the second one in bricks; painted wooden ceilings are also present. Some false ceilings with wooden structures were introduced under the roof in the renovation after the earthquake of 1703; at the same time, some partitions in wooden framework and doors with stucco frames were introduced.

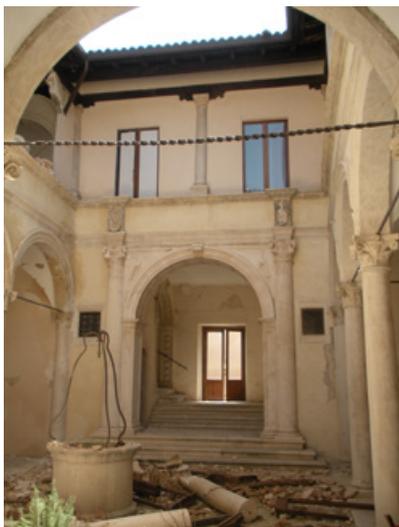
◀
From left to right:
Fig. 10. Palazzo Carli Benedetti after the earthquake: the courtyard (ph. Bartolomucci 2009)
Fig. 11. Palazzo Carli Benedetti after the earthquake: the collapse in the staircase (ph. Bartolomucci 2009)

The 2009 earthquake caused serious damage to the Palazzo Carli-Benedetti: the collapse of the northern upper loggia in the courtyard, the loss of the corresponding eighteenth-century inner ceiling vault (figg. 10, 12), the partial ruin of the staircase wall (fig. 11) and the extensive damage to walls, most pronounced on the upper floor. Luckily, no loss of life occurred.

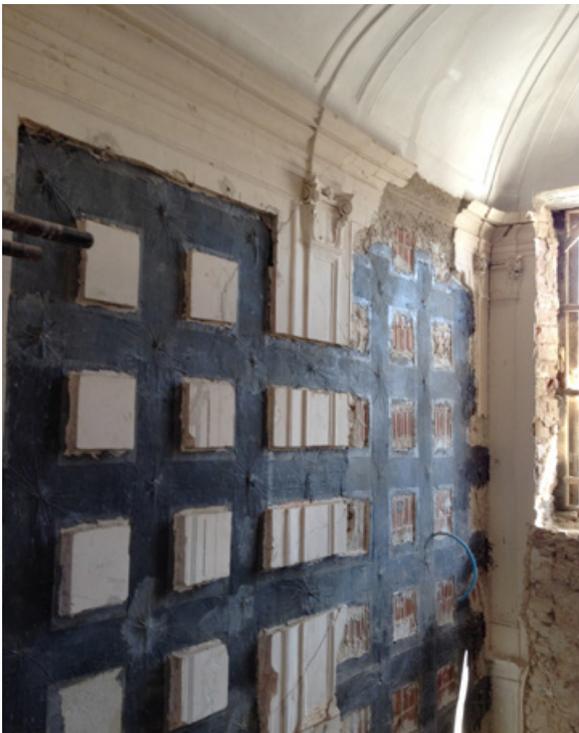
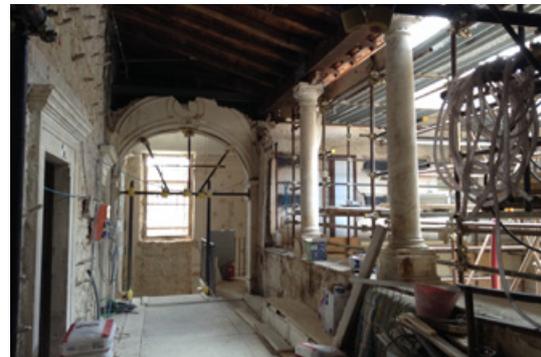
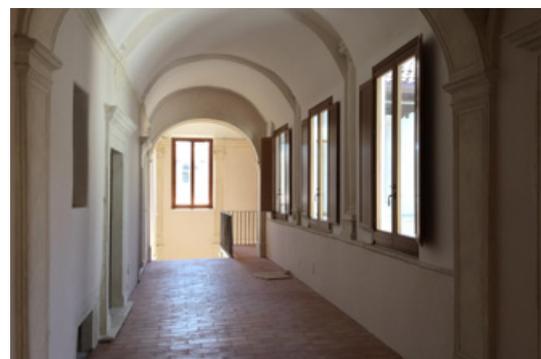
Fig. 15. The reconstruction of the loggia in progress: the collapsed columns have already been recomposed with anastylosis (ph. Bartolomucci 2015)

Fig. 17. Reconstruction of the walls surrounding the staircase: the damaged masonry was integrated and connected by FRP reinforcements (ph. Bartolomucci 2015)

The final choice was to reconstruct the fallen wall using thin panels so as to leave the columns visible inside and outside (fig. 16). This means that the new structure is distinguishable from the still preserved eighteenth-century façades (Bartolomucci 2018: 115, 125).

Similarly, the damaged walls were repaired and reconstructed in a recognisable way, using materials other than the original ones (fig. 17). The inner plans of the apartments have been carefully revised, looking

Following this criteria, integration of the missing parts of the walls and vaults have been done using traditional materials, mostly bricks, while the structural consolidation took advantage of the introduction of fibre-reinforced ribbons, located on the internal surface of the walls and above the vaults (figg. 17, 22).

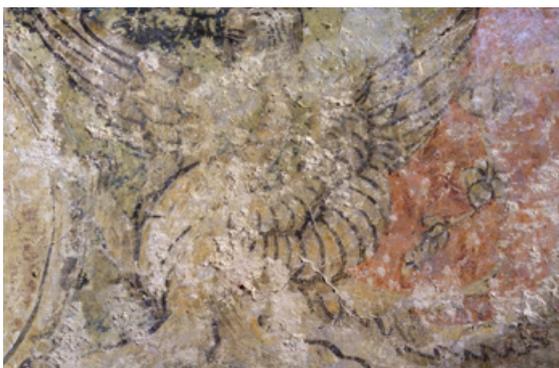
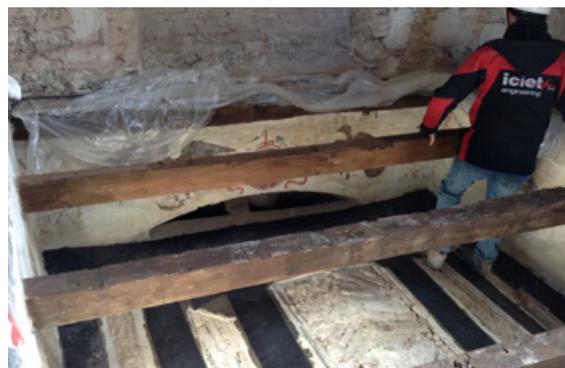
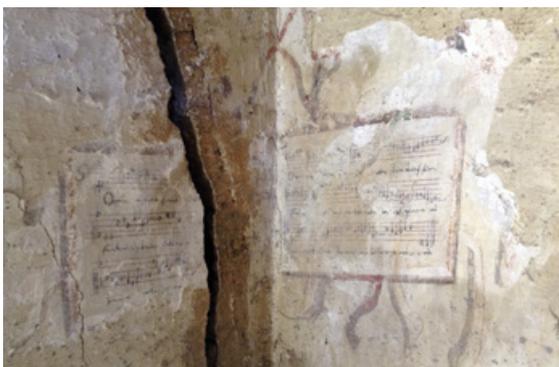
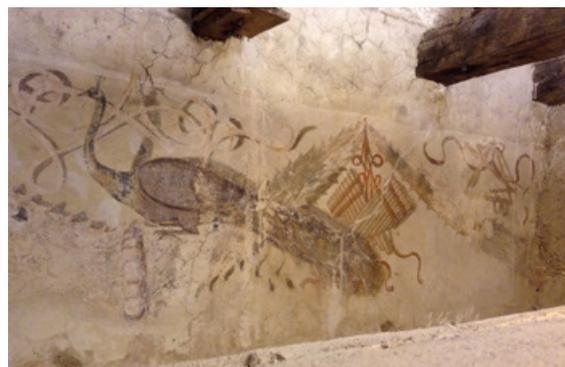
Fig. 21. Detail of the frescoes discovered under a fifteenth-century painted ceiling (ph. Bartolomucci 2015)

Fig. 24. Detail of a musical score discovered under the same floor, attributed to the early sixteenth-century. Note the wall damage, already repaired in the past (ph. Bartolomucci 2014)

The analysis of seismic damage revealed some pre-existing structural vulnerabilities caused by earlier renovations of the apartments: cracks in the masonry due to the insertion of services, changes in room layout and new openings cut through the walls. In addition, some modifications had altered previous configurations. In some cases, the false ceilings had hidden vaults, wooden roofs and wall paintings (fig. 18-20), in others, the superimposed layers of plaster and painting had covered frescoes from the fourteenth and sixteenth centuries (fig. 21).

Important decorative elements, totally unknown previously, were discovered: among them, paintings with musical scores and instruments, attributed to the early sixteenth-century (fig. 22-24). These discoveries meant that the project had to be modified and new authorisations had to be obtained, leading to a delay of a year in completing the project.

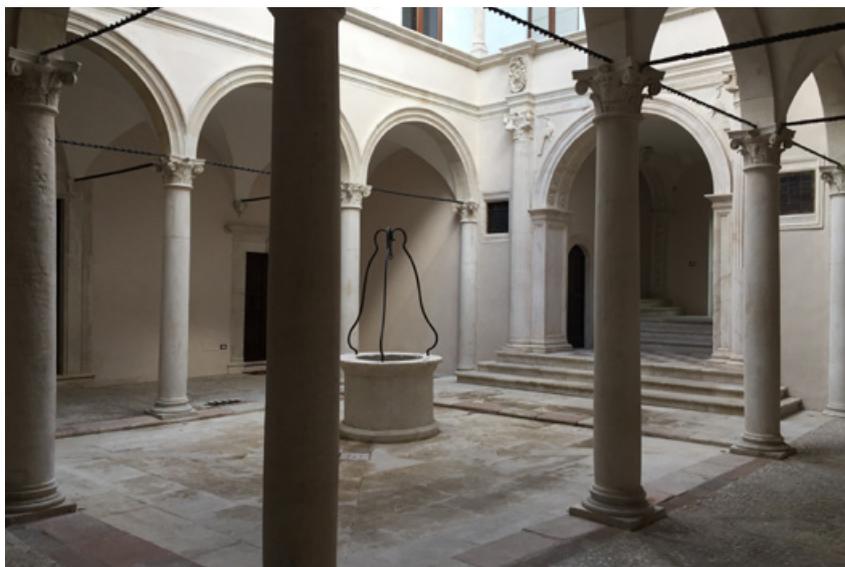
► **Fig. 25.** The courtyard at the end of the works: the air colour on the loggia returns the sense of the open loggia, without denying the eighteenth-century transformation (ph. Bartolomucci 2018).
