# Material Inspection of Historical Built Heritage with Multi-Band Images: A Case Study of the Serranos Towers in Valencia

**Abstract:** Built heritage materials assessment is an important task for planning and managing future conservation works. The uniqueness of each historical building makes reconnaissance operations more complex and specific for every single building. In the past, visual inspection and invasive techniques were widely used to investigate surface materials. Non-destructive techniques (NDTs) such as multi-band photogrammetry and remote sensing can help to assess the buildings without any contact with the investigated objects, restricting the disruptive tests on limited areas and reducing the testing time and costs of the surveys. This paper presents the results obtained using multi-band images acquired with a low-cost imaging solution after interchanging several filters, and the application of the principal components analysis (PCA) to recognize different materials of a significant historical monument. The Serranos Towers, built between 1392 and 1398, suffered several interventions in the past that affected their state of conservation with the replacement of diff

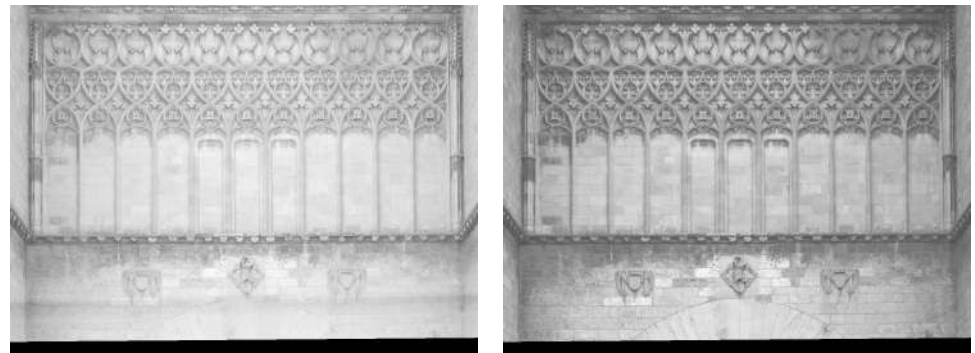
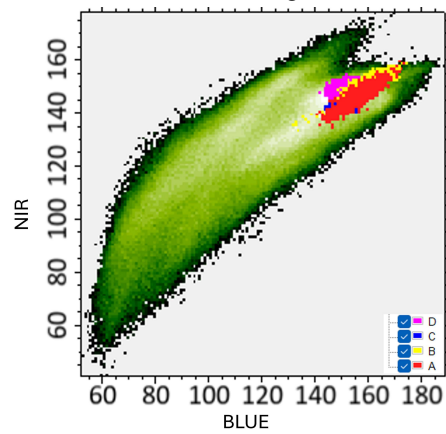
**Figure 3.** Single bands of the multi-band cube (a–e), and scatterplot between digital values of Blue and NIR bands (f).

First of all, NIR and NUV images were acquired as three color band images, so conversion into grayscale was required and it was obtained using a gray equal combination. Moreover, NUV and NIR images presented a slight shift and rotation effect with respect to the visible ones, due to minor camera movements while capturing the different filtered images. A warping process was performed to align the NUV and NIR images with the visible ones. This procedure required the measurement of some tie points and imposing a 2D transformation. Several transformation models can be selected in the function of the images used. For our purpose, the orthogonal transformation that preserves shape, allowing only translations, rotations, and a single scale change, was chosen. A least-squares transformation was used to minimize the error across the image with root mean square errors (RMSE) smaller than one pixel, measuring 5/6 tie points for warping the images. During this process, the images underwent a bilinear resampling, although no significant differences were found with other interpolation methods such as nearest neighbor and cubic resampling. Once the images were geometrically corrected, a multi-band image combining NUV, R, G, B, and NIR images (Figure 3) was created, yielding a 5-band cube. To obtain metric information on the main façade of the central body, a projective rectification of the images with 6 tie points was performed, merging the cube images with elevation maps achieved by the photogrammetric reconstruction during the survey of 2000–2002. This geometric transformation was suitable because the façade is flat; otherwise, an orthorectification would have been required [50].

PC5 (Figure 5a) highlights the presence of the two main materials in the tracery. It is important to underline that tracery is a mixture of different materials, processes, and substitutions from different periods. According to the material map (Figure 5b), obtained during pre-intervention studies conducted in 2000–2002 [46], the tracery is realized with 2 main stones, calcareous tuffs (letters A/B in Figure 5b), and dendritic stones (letters C/D in Figure 5b). In particular, the calcareous tuff “A” is a porous stone and occasionally conserves the original red coloration, as it is possible to see in the visible image (Figure 5c). The “B stone”, meanwhile, is a compact calcareous tuff. The difference between them is the different stones’ finish techniques (A is a carved stone and B is bush hammering), as can be appreciated in the scatterplot presented in Figure 4f, in contrast to the scatterplot presented with the input images at both spectral ranges (Figure 3f).

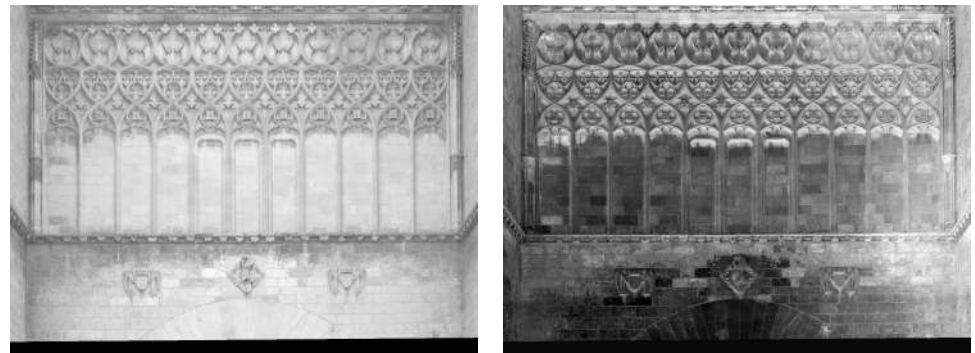
**Figure 4.** Principal components (a–e) and scatterplot between digital values of PC1 and PC5 bands (f).

The PCA was applied to the north façade of the Serranos Towers to analyze the tracery, the arch, and its surroundings. Five PCs (PC1, PC2, PC3, PC4, PC5) were obtained (Figure 4) from the 5 input bands (Figure 3). The last PCs, PC4 and PC5 in particular, gave interesting information about the construction materials in the investigated areas.

The “C group” has different subgroups, numbered from 1 to 5, that represent a particular treatment of the stones. Finally, another class, D, was identified and included in the class of dendritic stones that are too degraded to be assigned to the previous categories. For a complete description of the material composition of the tracery, see the book [46]. PC5 (Figure 5a) differentiates the A/B calcareous tuff stones (red square in Figure 5b) with respect to the dendritic ones (C/D stones). As stated before, A and B stones are calcareous tuff, and the difference lies in the stone’s finish technique: A is a carved stone, while B is bush hammering. The same applies to the stones C and D. The clear distinction between the two main stones A/B and C/D is shown in the scatterplot (Figure 4f).

Finally, the PC4 band highlights new stones in the upper part of the arch. During the prison period (1586–1872), the emblem upper the arch was replaced by a window, the latter was removed during the third recovery phase with the replacement of new stones different from the adjacent ones (Figure 8). Also in this case, as stated in [46], the replaced stones are “compact calcareous tuff”. Similar results are obtained in the upper part of the tracery. Comparing the results with the period construction hypothesis map, it can be seen that, in some cases (green box in Figure 8a), the stones are partially recognized, because they are affected by some degradation forms that should be further investigated; only one replaced stone is not recognized (red box in Figure 8a), despite being distinguished in PC4 (Figure 4d).

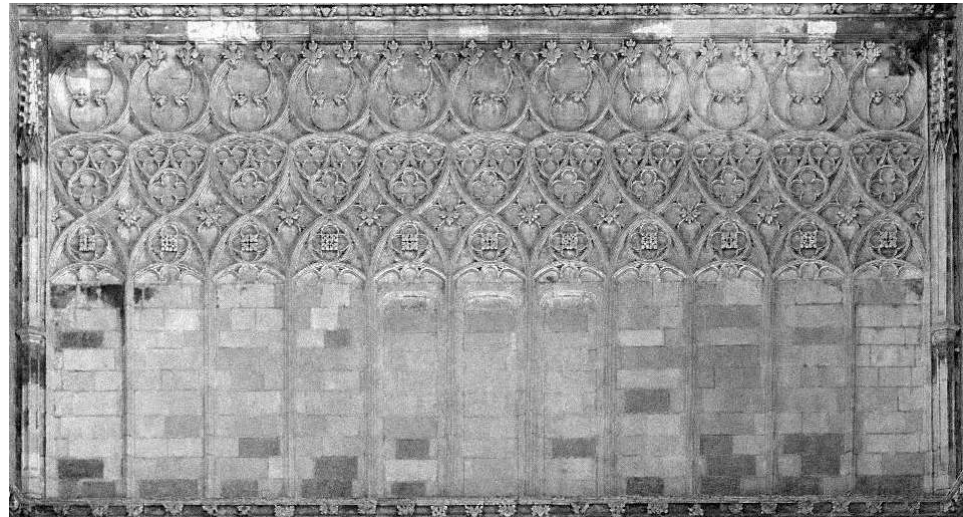
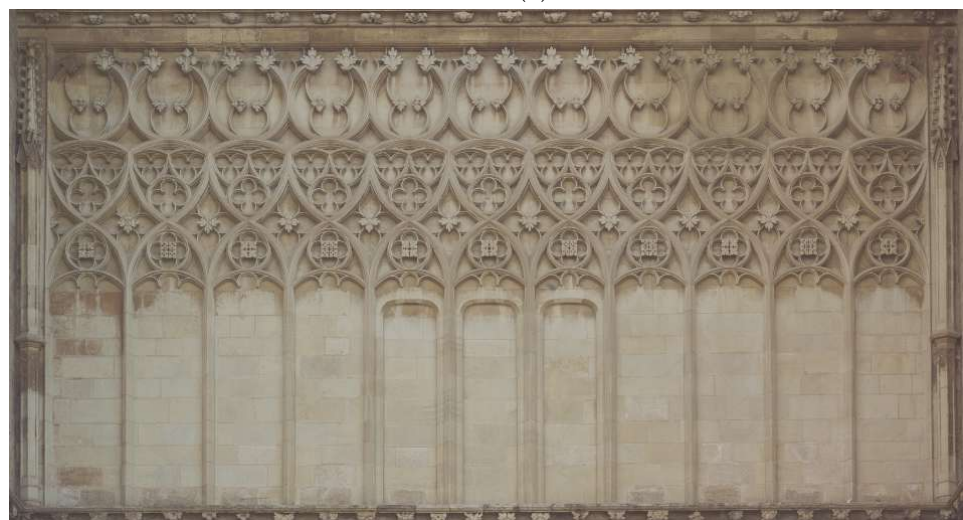
**Figure 5.** Tracery area on the north facade. (a) PC5 results; (b) comparison of PC5 with material map; (c) visible image.

In addition, PC5 shows two stones (highlighted in green in Figure 5b), depicted as calcareous tuffs and identified as dendritic stones (C and D) in the material map. After a deep and detailed new investigation of the data acquired in 2000–2002, a materials expert established that the two stones are calcareous tuff, confirming the utility of the method to identify “human error” based only on the visual inspection. The black and dark gray on the PC5 (Figure 5a) represent stones with red pigmentation, highlighted in blue in Figure 5b. Probably in the past, all the tracery was covered with this red layer, and today it is visible only on the original stones [46].

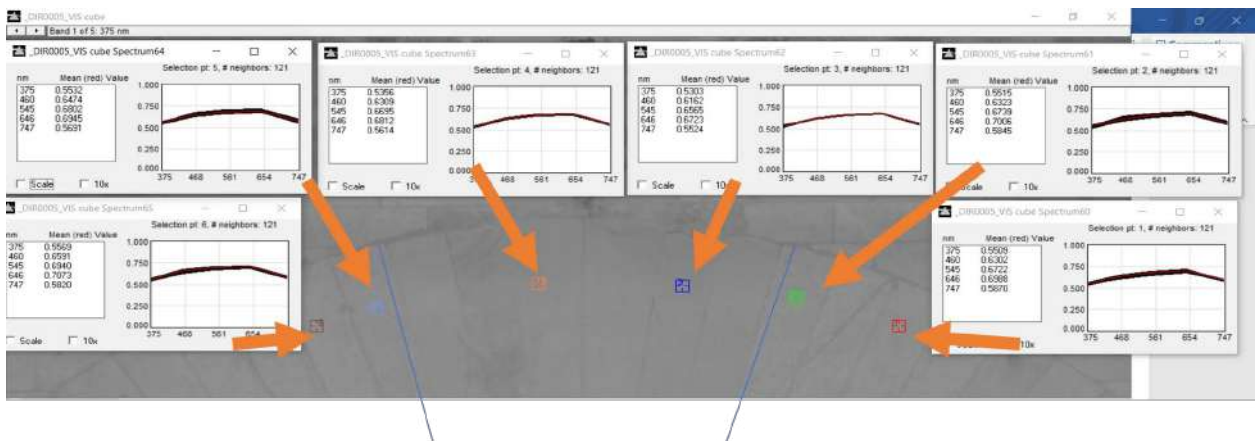
**Figure 7.** Spectral signatures of the calcareous tuff and compact calcareous tuff on the arch.

“Porous calcareous tuff” was the original stone used to build the arch. Rather, the stones that have been replaced are “compact calcareous tuff”, which is the type of stone that was primarily utilized for 19th century restoration. These two stones have similar spectral responses (Figure 7); therefore, it is very difficult to discern the differences based on the separability of the spectral signature only.
