# Operational Modal Analysis, Model Update and Fragility Curves Estimation, through Truncated Incremental Dynamic Analysis, of a Masonry Belfry

**Abstract:** Masonry towers, located in seismic zones, are vulnerable and prone to damages up to compromise their stability. The scatter of data on the mechanical properties of masonry, geometry and boundary conditions determine a lack of building knowledge on their expected behaviour. Therefore the assessment of the seismic capacity represents a critical task. This paper contributes to the issue of seismic analysis of masonry towers, focusing a meaningful case study: the St.Silvestro belfry in L'Aquila, Italy. The tower, severely damaged by the 2009 earthquake sequence, underwent extensive restoration works, endeavoured to mitigate its vulnerability. The observed seismic damage, the performed no-destructive testing campaign and the accomplished rehabilitation measures are described in the paper. The authors appraised the actual seismic performances of the St.Silvestro belfry, reinforced by the last restoration works. At first, the Operational Modal Analysis (OMA) is carried out to enhance building knowledge. In a second step, a refined f

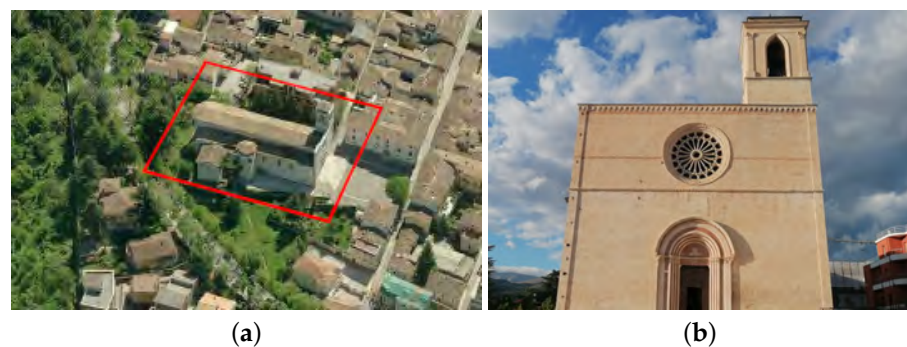
**Figure 2.** (a) Top view of the St.Silvestro Church (from <https://earth.google.com>, accessed on 15 March 2021); (b) View of the facade of the Church.

The complex of St.Silvestro is a medieval building, located in the centre of L'Aquila, Italy, see Figure 2a, composed of the church, the belfry, the canonical house, and the chapel (Figures 3 and 4).

Two masonry walls, 0.80 m thick and 5 m high, with six and seven ogival arches respectively, divide the naves between each other. The facade is in Gothic style, with a central rose window, Figure 2b. The belfry stands by the right side of the façade. It has a 5.5 m by 6.9 m rectangular plan and is 33 m high. A steel staircase reaches the bell cell, see Figure 7, distinguished by slender masonry piers and large openings.

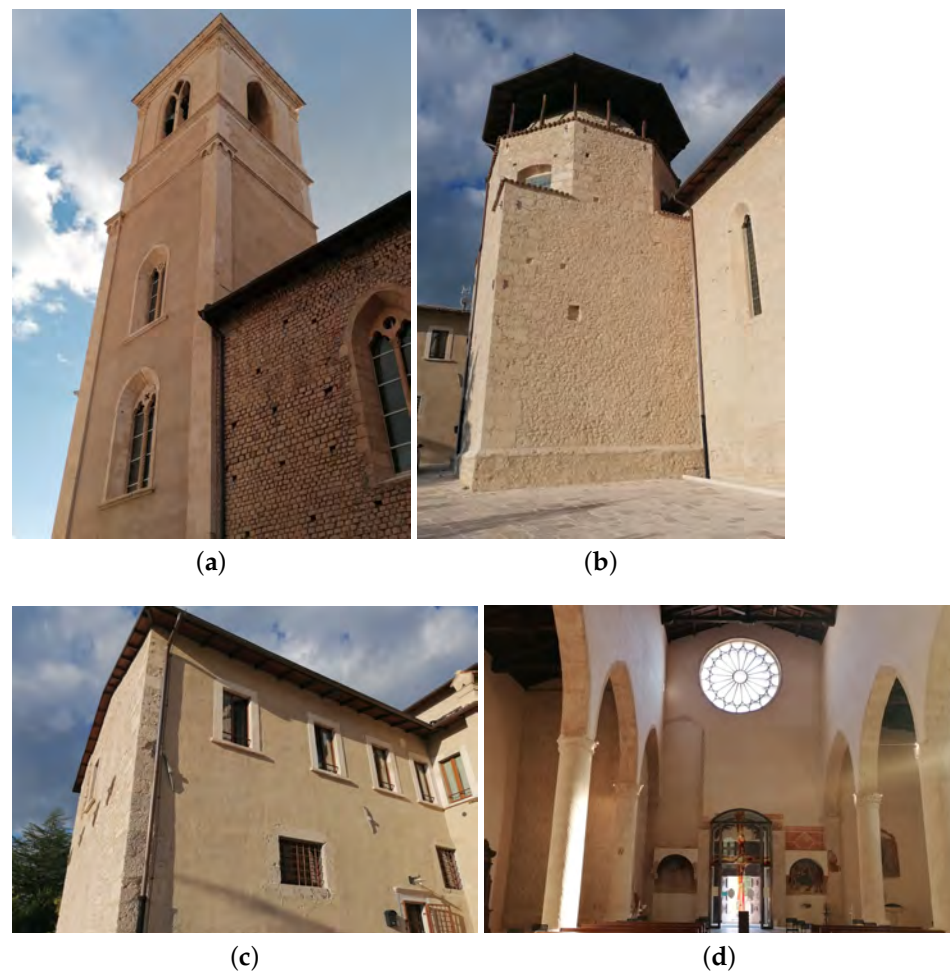
**Figure 4.** The St.Silvestro complex after the rehabilitation works following the 2009 earthquake: (a) Belfry, (b) Chapel, (c) Canonical house, (d) Interior of the church.

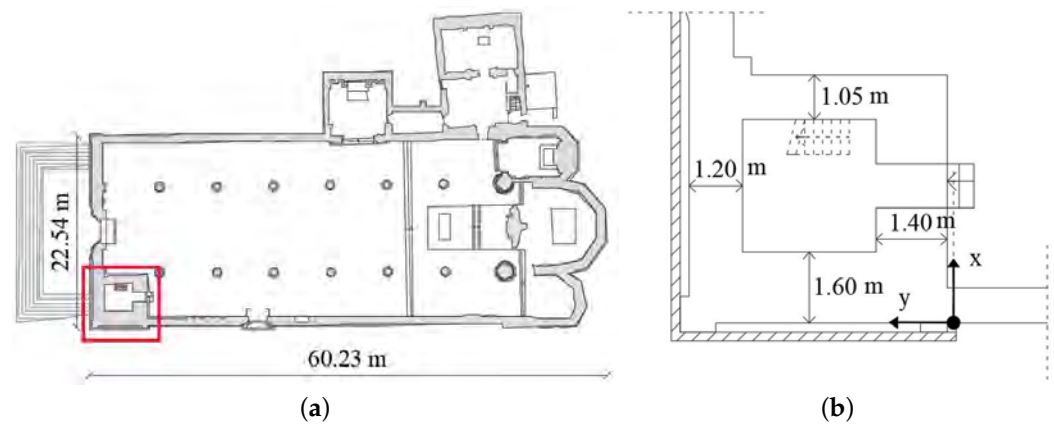
**Figure 6.** (a) Plan of the church: the red rectangle indicates the belfry; (b) Cross-section of the masonry tower.

Currently, the building exhibits the main features of medieval architecture. The church has a 60.23 m by 22.54 m rectangular plan, Figure 6. The interior consists of three naves: the length of the central nave is two times the length of the lateral ones.

The thickness of the belfry wall is not constant. It changes in correspondence with each wall: 1.05, 1.20, 1.40 and 1.60 m, Figure 6b. The belfry was erected using rubble stone masonry with lime mortar, see Figure 8a. A different type of masonry constitutes the lateral walls, with semi-regular ashlar units, shown in Figure 8b, the so-called “Apparecchio Aquilano”.

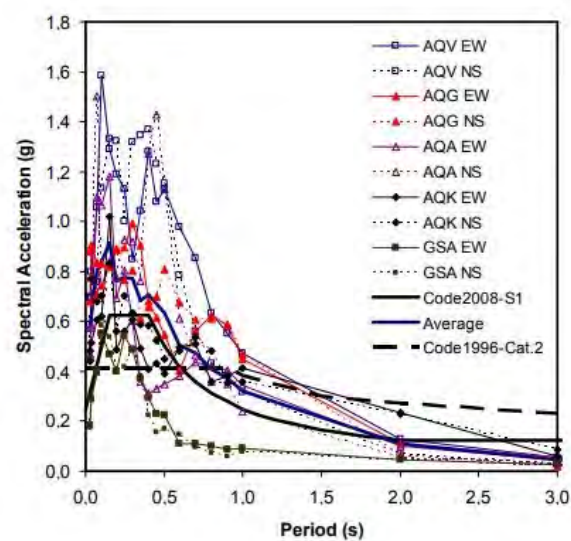
Figure 11. Response spectra of the records from 5 stations for damping and comparison with Normative code design spectrum [38].

On 6 April 2009, at 3.32 a.m., an earthquake with  $M_w = 6.3$  struck L’Aquila and the central Apennines. The epicentre was located 10 km west of L’Aquila and 95 km east of Rome. The earthquake originated from the motion of a normal fault in the North-South direction [37]. The main-shock was the third earthquake event by intensity, occurred in Italy since 1972, after the Friuli event, recorded in 1976 with  $M_w = 6.4$ , and the Irpinia event, recorded in 1980 with  $M_w = 6.9$ . The response spectral acceleration of the records of the earthquake is reported in Figure 11.

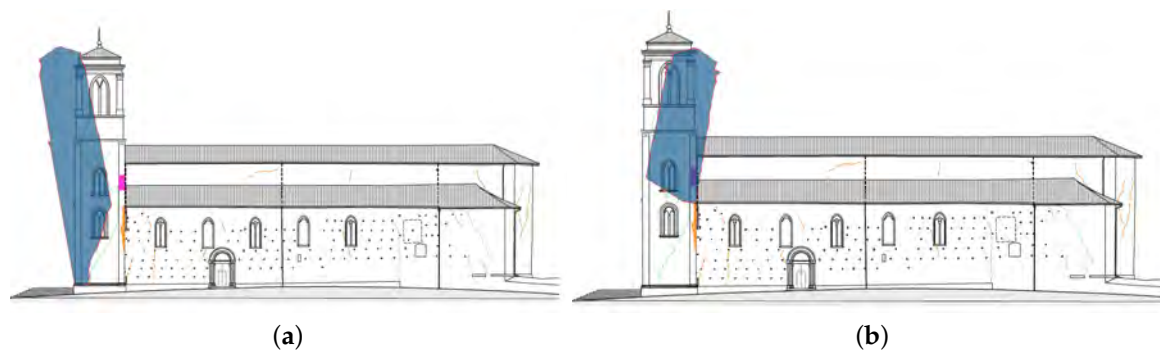
Figure 14. Observed collapse mechanism of the St. Silvestro belfry: (a) The first overturning; (b) The second overturning.

The first mechanism affected the entire belfry, which pivoted around a cylindrical hinge located at the base, depicted in Figure 14a. The second mechanism involved the upper part of the belfry, which pivoted around a cylindrical hinge at 10.20 m, as pictured in Figure 14b.

Both mechanisms caused severe diagonal cracks. The lack of connections among different structural parts gave rise to local mechanisms also in other components of the monumental complex.

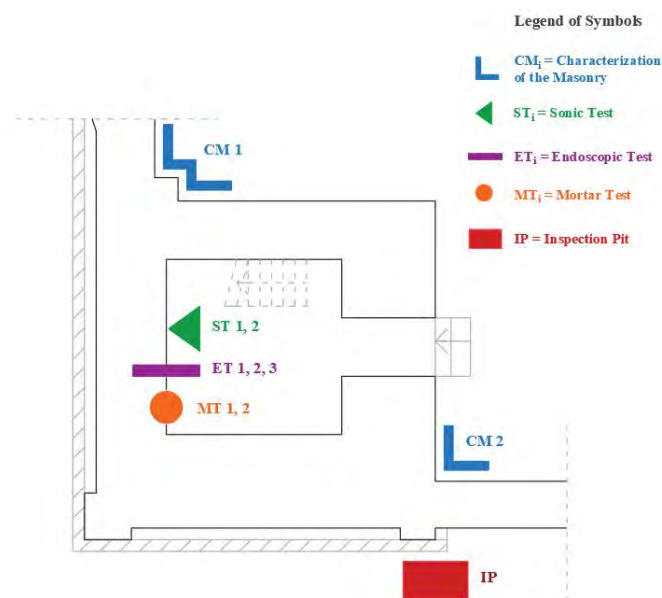
Figure 15. Plan of the diagnostic tests on the belfry.

After the 2009 earthquake, the Fine Art Authority carried out a non-destructive testing campaign to enhance structural knowledge. Regarding the belfry, Figure 15 illustrates the locations of the tests.

The endoscopy technique manifested the arrangement of the masonry units inside the wall, in three different locations: 2.5 m (Endoscopic Test ET1), 8.5 m (Endoscopic Test ET2) and 14.5 m (Endoscopic Test ET3), measured from the floor of the belfry. Masonry consists of irregular units, in local stone, arranged with mortar heterogeneously. According to the results of the three chemical-physical analysis (Chemical-Physical Analysis CPA1, CPA2, CPA3, in the points illustrated in Figure 15), the mortar composition consists of calcareous aggregate, with a negligible silica fraction, and a hydraulic binder, with a small aerial fraction. The sonic investigation technique allowed a more deep characterization of

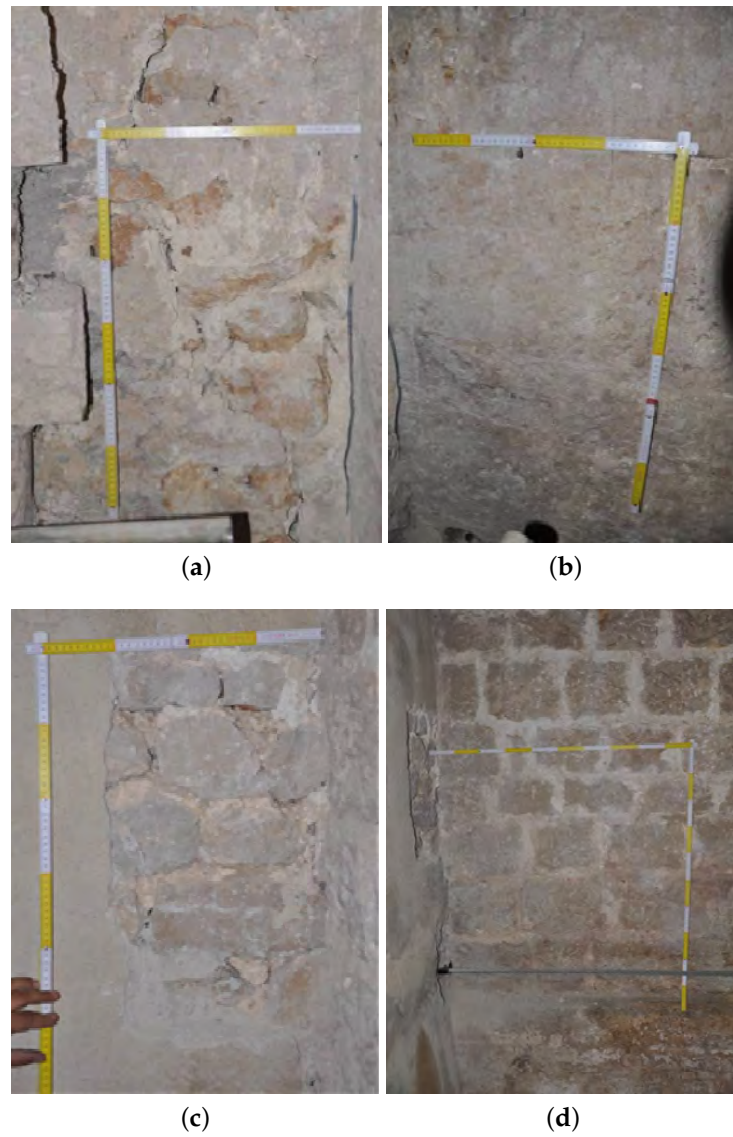
**Figure 16.** Characterization of the masonry surveys: (a,b) views of the first test, CS1; (c,d) views of the second test, CS2, taken by Fine Art Authority.

Two visual inspections, called CS1 and CS2, are carried out to characterize the connection between different structural parts. The investigations highlighted the lack of the connection between the belfry and the adjacent building: the photos Figure 16a,b show the different textures of the facade and the belfry wall (CS1), Figure 16c,d the nave wall and the belfry wall (CS2).

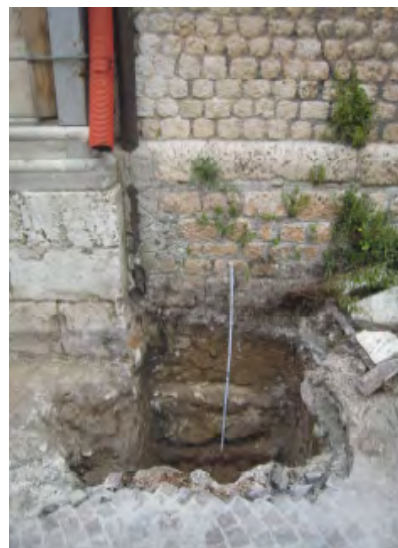
**Figure 17.** Photo of the inspection Pit, IP, near the foundation of the belfry, taken by Fine Art Authority.

An inspection pit IP, see Figure 17, investigated the foundation of the belfry: it consists of squared unit stones, nearly 0.6 m high.

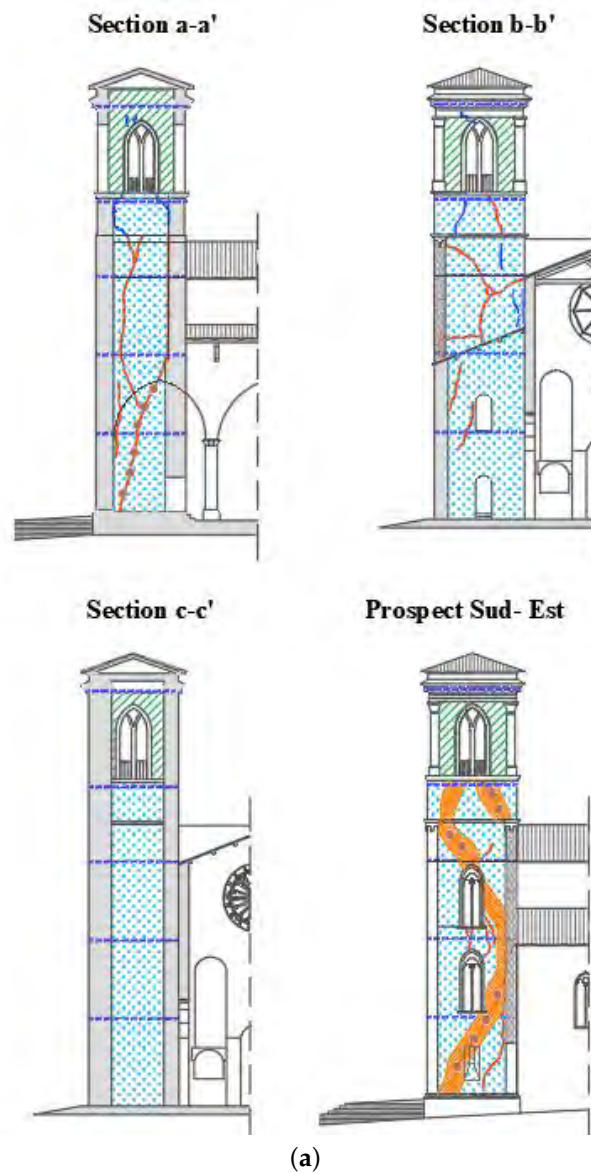
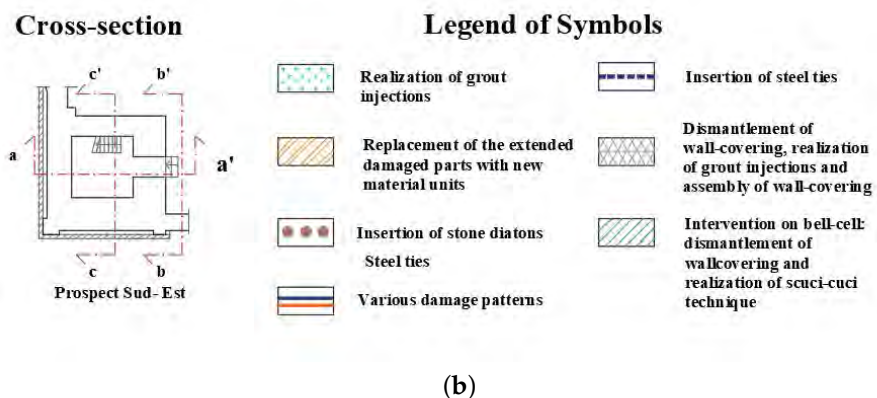
**Figure 18.** Restoration of the St.Silvestro belfry: (a) Representation of the restoration measure; (b) Cross-section and legend.

The rehabilitation interventions attempted to increase the overall structural response by preventing local collapse mechanisms. Specifically, the belfry was repaired differently, depending on the severity of the damage. The use of mortar injections allowed the repair of the more superficial cracks. The parts with extensive damage were replaced with new bricks. Stone diatons reinforced the wider cracks, by connecting the rupture surfaces, and improved the friction resistance among the masonry units. Expectedly, the reinforcement enhanced the global structural behaviour of the tower, primarily due to the contribution of the steel rods which connected the walls between each other. Furthermore, the grout injections improved the overall mechanical performance of the masonry. The brief descriptions of the interventions on the belfry are depicted in Figure 18.

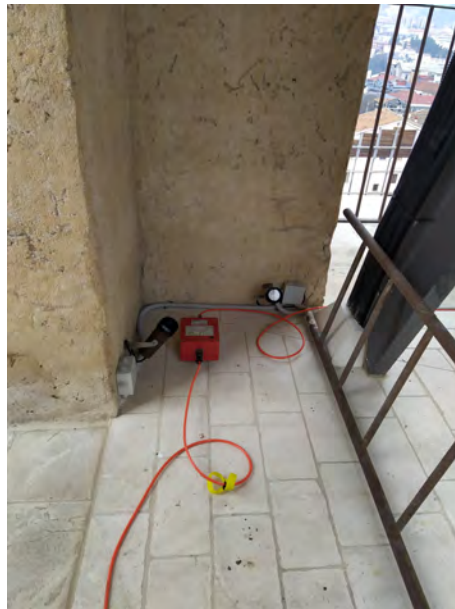
Figure 19. Accelerometer placed on the top of the bell tower, at the height of 22.03 m.

A set of 10 Force-Balance mono-axial accelerometers (SARA Instruments SA10) was used, see Figure 19. The accelerometers are characterized by a dynamic range higher than 165 dB in the frequency interval 0.1–20 Hz and a 5 V/g sensitivity. The authors used two measurements chains for the acquisition system, each one driven by a master recorder unit, synchronized by a GPS sensor.

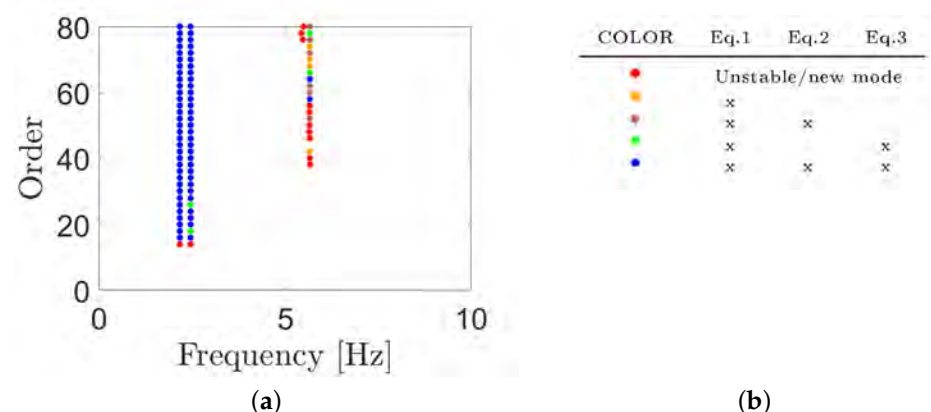
**Figure 21.** (a) Stabilization diagram obtained from SSI-cov analysis; (b) Legend of the colors.

In order to graphically verify the stability of the poles as the order of the system increases, the authors implemented the following stabilization criteria:

Unfortunately, the ambient excitation did not sufficiently excite the upper modes: the complex is located in a traffic-free zone, leading to a low ambient excitation level. Only two modes, described in Table 2, arose clearly from the stabilization diagram, which is reported in Figure 21a. The experimental results were quite satisfactory: the Modal Phase Collinearity values, MPC, were equal to 0.91 and 0.86, respectively.

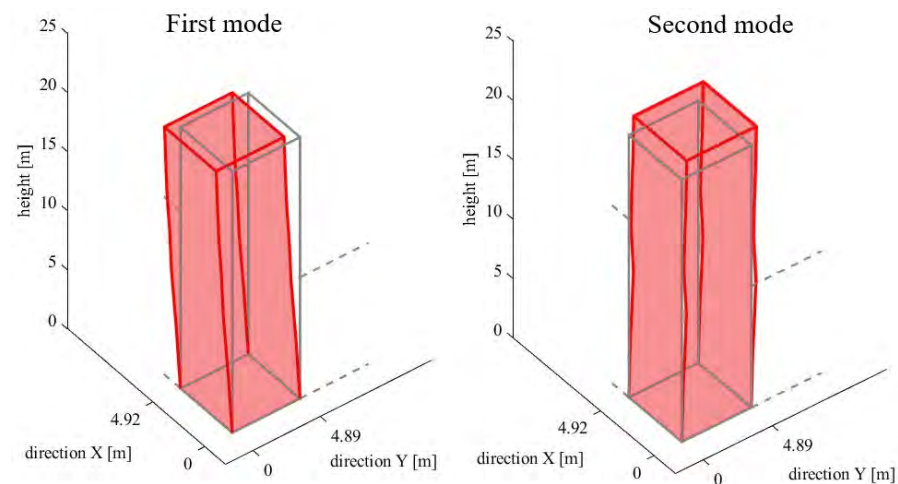
Figure 22. Experimental mode shapes.

The modes are translational in two orthogonal directions, see Figure 22.

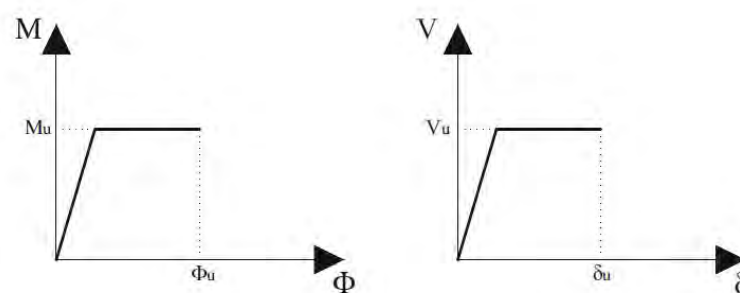
Figure 23. Plastic hinge law for masonry elements.

Numerical analyses were carried out to assess the dynamic response of the belfry. Specifically, the authors developed a Finite Element (FE) model, using an equivalent frame model, implemented in SAP2000, a software package user-friendly interface widely used for seismic analysis. The experimental results pointed out a global behaviour of the belfry, justifying the development a global model. The Finite Element model, based on a simplified modelling approach, ensures good results for global analysis of masonry structures in the nonlinear field [45,46], allowing also to reduce the computational costs of nonlinear analyses. The chosen approach consists in modelling each masonry wall with an equivalent frame, connected each other by rigid links. The reliability of this modelling approach was investigated by several scholars, also in the case of historical structures [47–49]. The nonlinear mechanical behaviour descends from a so-called lumped plasticity approach [50]. The walls are modeled as elasto-plastic with two rocking hinges, located at the ends of each frame, and a shear hinge, located at the mid-height. The masonry elements may exhibit in-plane failure for bending-rocking and shear sliding mechanisms: the constitutive law is represented in Figure 23.

The ultimate shear displacement is equal to 0.4% of the deformable height of the masonry element and the ultimate rotation, for bending moment, is equal to 0.6%. The mechanical parameters of the un-reinforced and reinforced masonry were assigned according to the Italian Standard Code [21], see Table 3. The correction factor accounts for the effectiveness of the different strengthening interventions on the mechanical characteristics of the masonry: equal to 1.7 for grout injections and equal to 2.55 for grout injections and stone diatons, as suggested by [21]. In detail, the masonry properties of the walls in X-direction were improved by grout injections. Additionally, the walls in Y-direction had consolidations using diatons. These values of the elastic modulus  $E$  provided the starting value in the model updating process.

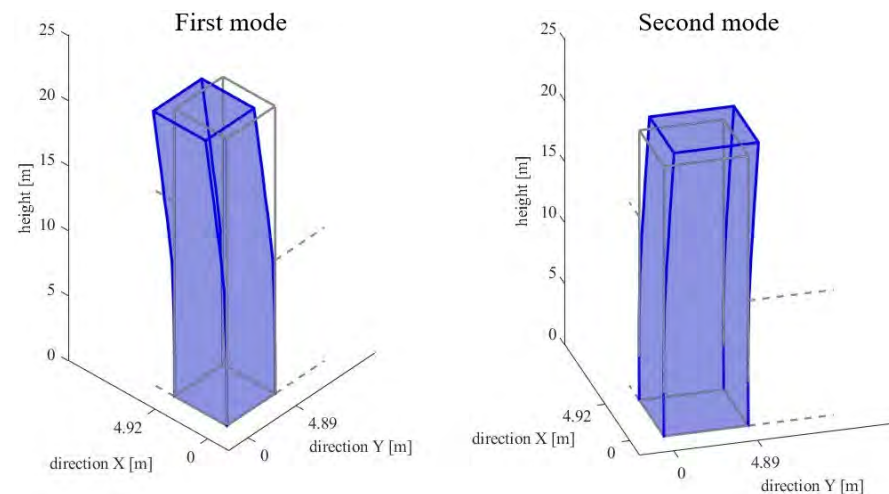
Figure 24. Numerical shapes after the model updating.

Figure 24 illustrates the translational modes revealed by the numerical analysis after the model updating.

Table 4 reports the comparison between the numerical and experimental frequencies of the structure and their relative discrepancy.

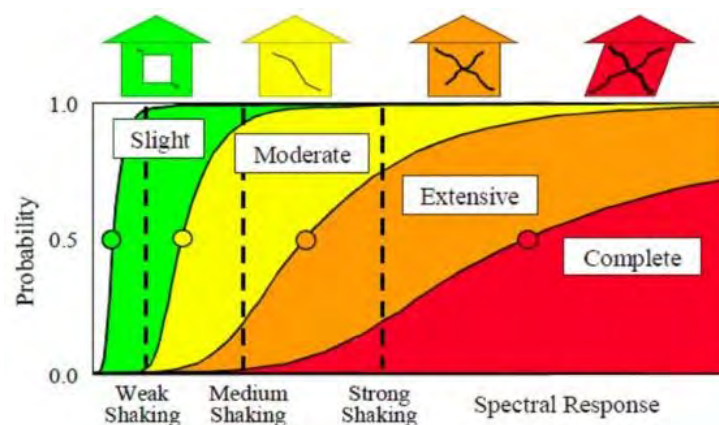
Figure 26. Example of a fragility functions, as reported in FEMA.

According to FEMA [57], the damage limit states,  $d_s$ , are given by the expression in Equation (8).

$$P(C|IM = x) = \Phi\left(\frac{\ln(x/\theta)}{\beta}\right) \tag{9}$$

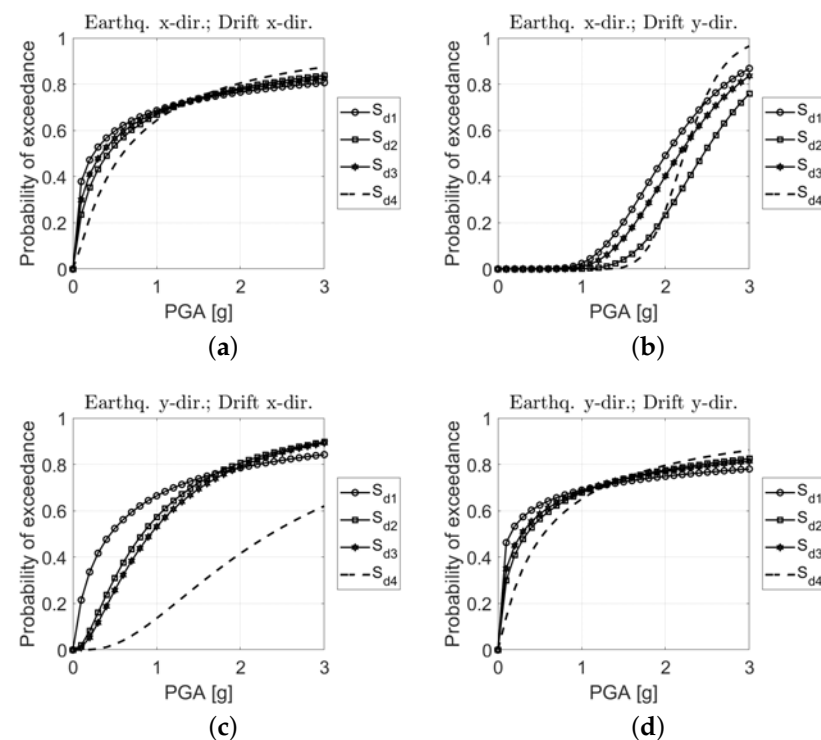
**Figure 27.** Fragility curves of the masonry tower based on numerical results: (a) Earthquake in X direction, drift in X direction; (b) Earthquake in X direction, drift in Y direction; (c) Earthquake in Y direction, drift in X direction; (d) Earthquake in Y direction, drift in Y direction.

Figure 27 shows the fragility curves obtained from the above procedure. The X-direction is more vulnerable than the Y-direction. The earthquake action yields significant drifts in each direction of application, see Figure 27a,b. Conversely, the drifts are negligible in the perpendicular direction and give lower failure probabilities, see Figure 27c,d. As already discussed, the restoration works not affected the walls homogeneously, leading to different mechanical parameters of the masonry of the wall in the two directions. Moreover, the openings are different in terms of position and size in the two directions, influencing the in-plane capacity of the walls. Conclusively, the horizontal restraint offered by the surrounding building is not the same for the facade and nave wall. This evidence lead to the difference of collapse probabilities in the two directions.

The occurred damage of MTs, after a seismic event, highlight their vulnerabilities and the low seismic safety level, requiring in-depth knowledge of the structure to determine appropriate strengthening measure. The cultural and historical value with the uncertainties inherent in Mts leads to the need for an experimental diagnostic campaign that reveals valuable information of the structure which are challenging to detect from visual inspection. Thus, dynamic experimental data allow to refine and update a numerical model in order to estimate the real structural behaviour. The authors present the results obtained from an experimental investigation, which has allowed to estimate the first modal parameters of the St.Silvestro belfry, in L'Aquila (Italy), after the rehabilitation works following the 2009 earthquake. The modal updating technique led to the calibration of a Finite Element model using the experimental model parameters. The obtained elastic modulo,  $E_x = 3540$  MPa and  $E_y = 3360$  MPa, fall into a satisfactory range of values, corroborating the effectiveness of the strengthening measure carried out. The diagonal Modal Assurance Criterion values evaluated between numerical and experimental modes were equal to 0.782 and 0.885 respectively, demonstrating the reliability of the numerical model to grasp the seismic performance of the structure. The refined model was used to derive fragility functions from nonlinear dynamic analyses. The fragility estimation highlighted different probabilities of collapse in the two directions of the earthquake. The most vulnerable direction is the X direction. Additionally the fragility curves revealed peculiar evidences: the earthquake action yields significant drifts in each direction of application. Conversely, the drifts are negligible in the perpendicular direction and give lower failure probabilities.
