COLLAPSE ANALYSIS OF SANTO STEFANO TOWER USING APPLIED ELEMENT METHOD

During the 2009 L'Aquila earthquake, the tower of Santo Stefano di Sessanio, the town's iconic symbol, collapsed to the ground. The tower was believed to have been rendered vulnerable to collapse because of 20th-century renovations to the tower's observation platform, which replaced a wooden deck with one made of reinforced concrete, thus making the tower top-heavy. In the current study, a numerical analysis was used for investigating the collapse behavior of the tower. Doing an initial elastic model of the tower did not allow any realistic prediction of the anomalous seismic behavior showed by the tower; the reason why only a stump of structure actually survived the earthquake remained unexplained. The collapse of the Medici tower is then investigated using a full 3D Applied Element Method (“AEM”). AEM is a discrete crack approach method in which the structure behavior till its collapse is followed. Two models for the structure of the tower were considered in this study. In the first model, the walls were modeled as regular brick elements neglecting the random real shape of the stones of the tower, while in the

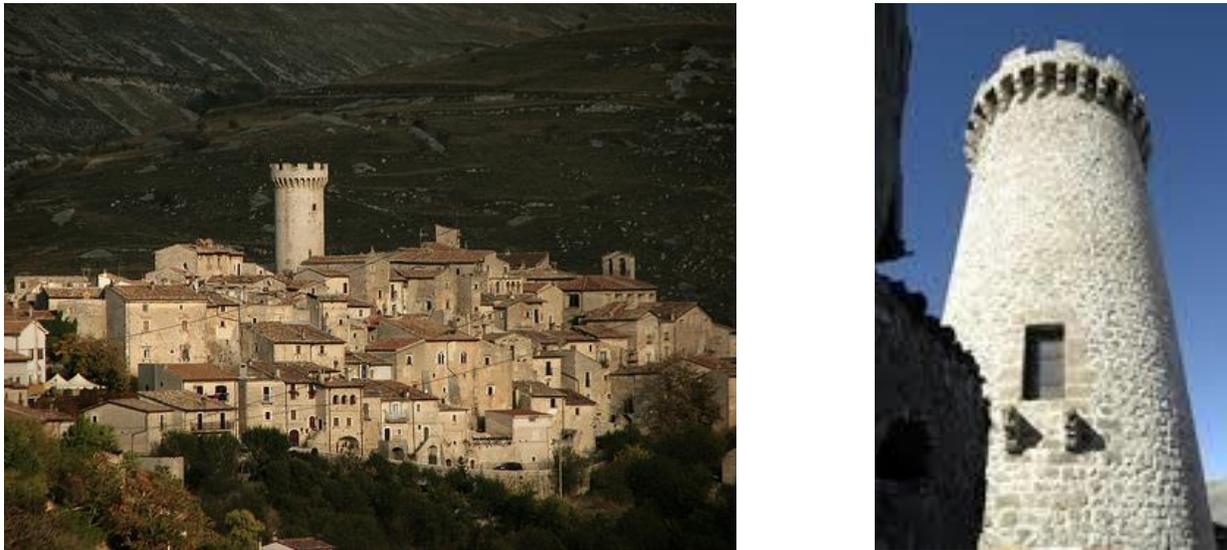
Fig. 1 – a) A picture of Santo Stefano village; b) the Tower.

Santo Stefano village develops all around and below the medieval tower, which is located in elevated, eccentric position with respect to the historic core of the village (Fig. 1a). The tower has a circular cross section characterized from an internal diameter of about 3.89 m and a relevant wall thickness measuring about 1.50 m. From inside, the vertical development of the tower measures about 17.35 m. From outside, the overall height of the tower reached about 20 m. In additions to the tower entrance, which is located at the very bottom of the construction, two small openings are found along the cylindrical body of the tower. One is located at the height of about 3.80 m from the bottom of the tower and the second consists of a narrow window set closer to the tower top end. The lower opening is surrounded by regular stone blocks of average dimension. Two stones stand like cantilevers on the left and right sides of this opening (Fig. 1b) and were probably part of a medieval drawbridge system. The narrow window on top of the tower is located in the opposite direction compared to the entrance opening. On top of the tower, a crown of cantilevers sustains a crenellated parapet. Before April the 6th, 2009, the tower was open to people to could access the tower crown by means of the internal wooden staircase. These two flights of staircase were very narrow flights with a steep slope of about 116% stopping on wooden landings repeating every 4.60m in height (Fig. 2 a, b, c) During the Second World War a concrete floor was built on top

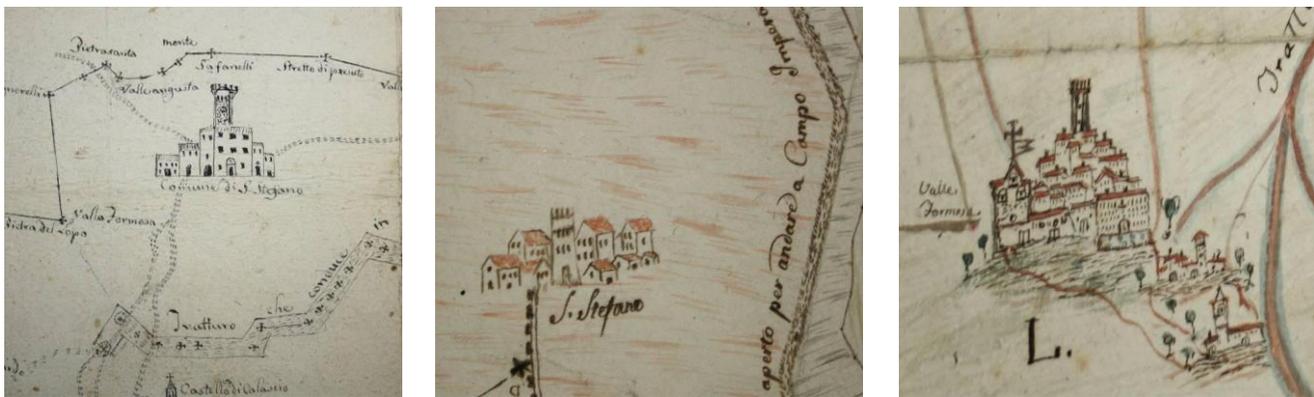
Fig. 4 – Drawings of Santo Stefano village on historical maps.

Actually, the history of the tower corresponds to that of the village of Santo Stefano di Sessanio, considered to be one of the most beautiful in Abruzzo (Italy). The first settlements of the village date back to the period of the Middle Ages. Actually, the historian Anton Ludovico Antinori (1704-1778) stated he found the words "Santo Stefano" in documents dating back to the year 1195. Originally, the tower was built as a cylindrical body with no crowning on top. The entrance used to be set at an elevated position and probably served by a drawbridge system. Since 1350, due to changes in the military techniques and to disastrous events, some modifications were done to the original tower shape. It is during the Angioins domination's period that the tower is doted of its crenellated parapet to serve as a real defense presidium for the village. Since 1550, regular maintenance was operated on the tower, with restoring interventions carried out as consequence of earthquakes and wars. Starting from 1791, the Santo Stefano village and its tower have been frequently represented in several historical drawings and maps (Fig. 4).

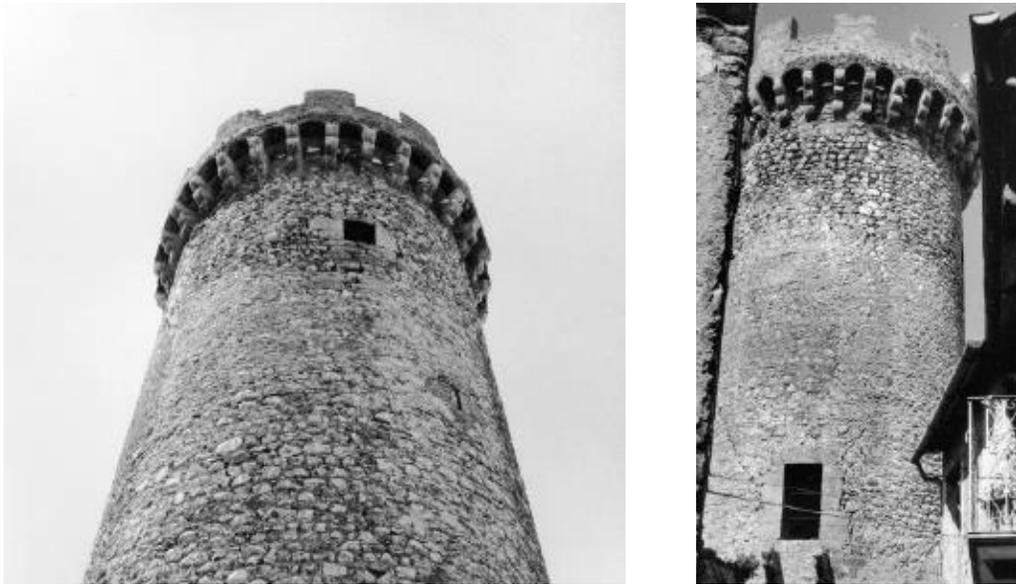
Most recently, during the '80s, the Office of the Superintendence to the Monumental Goods documented a diffuse cracks pattern and other damages related to aging. Pictures in Fig. 5 show the severe degradation suffered by the external surface of the wall characterized from loss of stones and cementing material, especially from top of the tower. Specific restoring interventions were carried out. As mentioned earlier, during the Second World War a concrete platform was built on top of the tower to use it as anti-aircraft station (Fig. 6a). Surprisingly (or probably not!), this rigid, heavy concrete slab separated from the tower and felt down almost untouched as consequence of the April 2009 earthquake (Fig. 6b).

Fig. 5 – The severe degradation of the tower as recorded during the 80's.
