Engineering Failure Analysis

Mode-I fracture toughness of hygrothermally aged curved filament-wound carbon and glass fibre composites

ABSTRACT

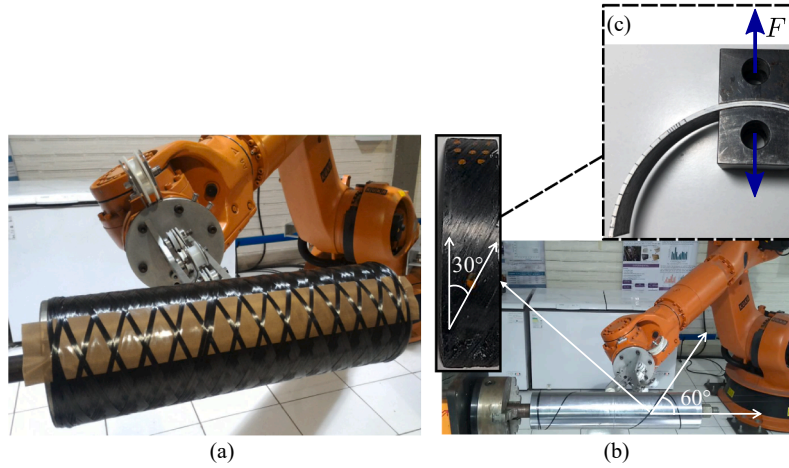
Fig. 1. (a) Use of the PTFE film during winding, (b) fibre angle illustration, and (c) specimen glued to the ending blocks for the CDCB test.

are hereafter referred to as $\pm 0^\circ$, $\pm 15^\circ$, $\pm 30^\circ$ and $\pm 45^\circ$, respectively. This way, the transverse-like CDCB specimen could be a reasonably pure Mode-I crack opening [27]. Fig. 1(a) shows the insertion of the PTFE film during the manufacturing at the neutral axis of the laminate, while Fig. 1(b) illustrates the angle difference comparing manufacturing and testing.

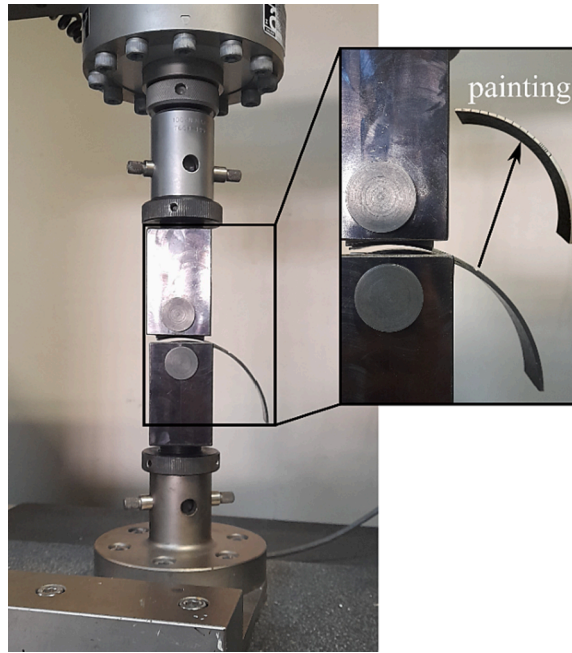
Fig. 2. Illustration of the testing rig.

The CDCB tests are carried out following the recommendations of the ASTM D5528/5528 M-21 standard. Although this standard focuses on flat samples, this is the closest standard available as a guide to these tests. The lateral surfaces of the samples are painted white to monitor crack growth, and the ending blocks (radius of 68 mm) are attached to the sample with the adhesive. The ending blocks + specimen system (Fig. 2) is then attached to an Instron (model 3382) Universal Testing Machine with a 100 N load cell.

The CDCB test (Fig. 2) is performed in two steps. Firstly, the pre-crack grows up to 2–5 mm to remove eventual resin pockets or other defects that arise from the PTFE tape insertion at the crack front, for more reliable results. The system is then fully unloaded until zero displacement with a constant crosshead displacement of 8 mm/min. After that, the actual test takes place with a crosshead speed of 1 mm/min, which corresponds to the lowest suggested by the referred standard. The crack tip is monitored with a digital microscope (maximum zoom of $1600\times$) for correlating applied load, crosshead displacement and crack extension. The definition of the crack initiation point is conducted using the VIS point technique. In general, such a load–displacement curve is composed of a quasi-linear part that corresponds to the crack initiation when the load reaches the peak value and a crack propagation region after that. The load smoothly decreases in the case of stable crack propagation. Nevertheless, a potentially unstable crack propagation may cause a sudden load drop. As mentioned, the crack extension is monitored visually and correlated to the load applied by the testing machine and the related displacement at every 5 mm of crack extension.

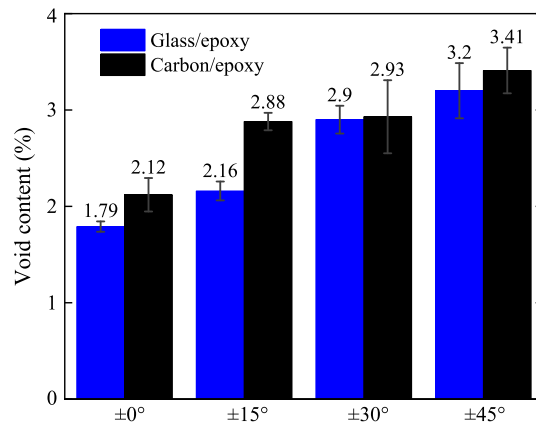
Fig. 3. Void content for non-aged glass/epoxy and carbon/epoxy composites.

The water uptake of the composite structures is closely related to the voids, which can be seen as resin air pockets. In Fig. 3, the mean and standard deviation values of void content for all specimens are presented. The lowest void content was found for the hoop wound samples and the highest for the $\pm 45^\circ$ winding angle, perhaps due to the lower tow tensioning during winding. Besides, the standard deviation generally increases from $\pm 0^\circ$ to $\pm 45^\circ$, especially for glass/epoxy, indicating more heterogeneous samples.

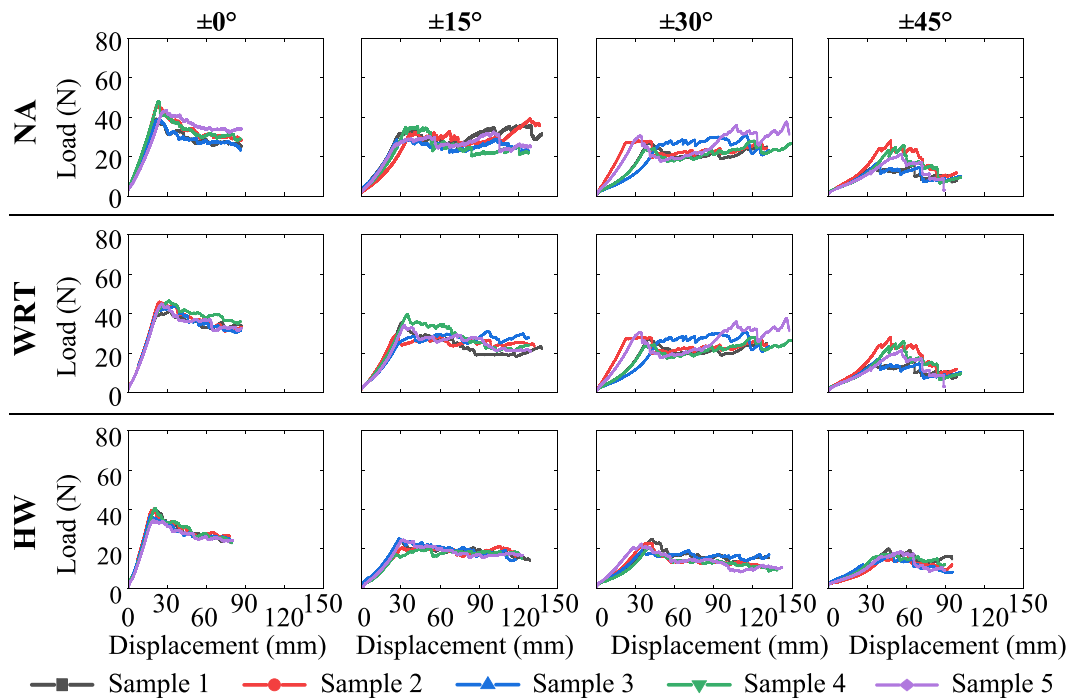
Fig. 5. Load-displacement curves for glass/epoxy composites under Mode-I fracture toughness (NA: non-aged, WRT: aged in water at room temperature; HW: aged in hot water).

The load–displacement (l-d) curves of all samples are presented in Fig. 5, for glass/epoxy, and in Fig. 6 for carbon/epoxy. The curves are organised based on fibre angle (columns) and type of ageing (rows). For the glass/epoxy samples (Fig. 5), the following considerations can be made:

- The l-d curves suggest that the higher the fibre angle, the less stable is the crack propagation. The crack growth is very stable for the ± 0° samples, regardless of the ageing. Very unstable crack propagation is observed for the ± 30° samples, again due to the variation in stiffness, and the unfavourable helicoidal winding angle that prevents the crack from growing smoothly. The higher the fibre angle, the higher the peak load, since the fracture energy is highly dependent on the alignment of the fibres with the applied load;

- The different types of ageing do not significantly affect the shape of the curves. In general, hygrothermal ageing at room temperature does not significantly affect the peak load and shape of the curves. However, the ageing at 70 °C affects the composites in such a way that the peak load decreases for all fibre angles. Despite that, crack propagation is more stable for all fibre angles, especially for the specimens wound at ± 30°, which are very unstable when non-aged or aged at room temperature; and

- In general, the ageing at 70 °C yields more stable crack propagation in all samples.
